PICTURES PAGE

Report # : Dobson medical 1

Dobson Medical
Chandler, AZ 85224

DEC Building Consultants

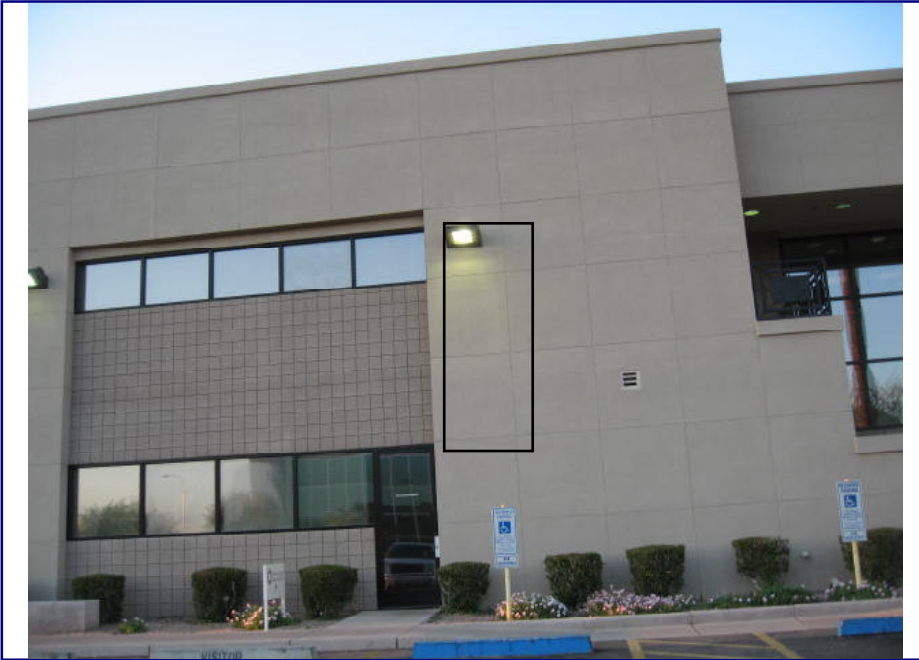
Picture 1

south face of the property

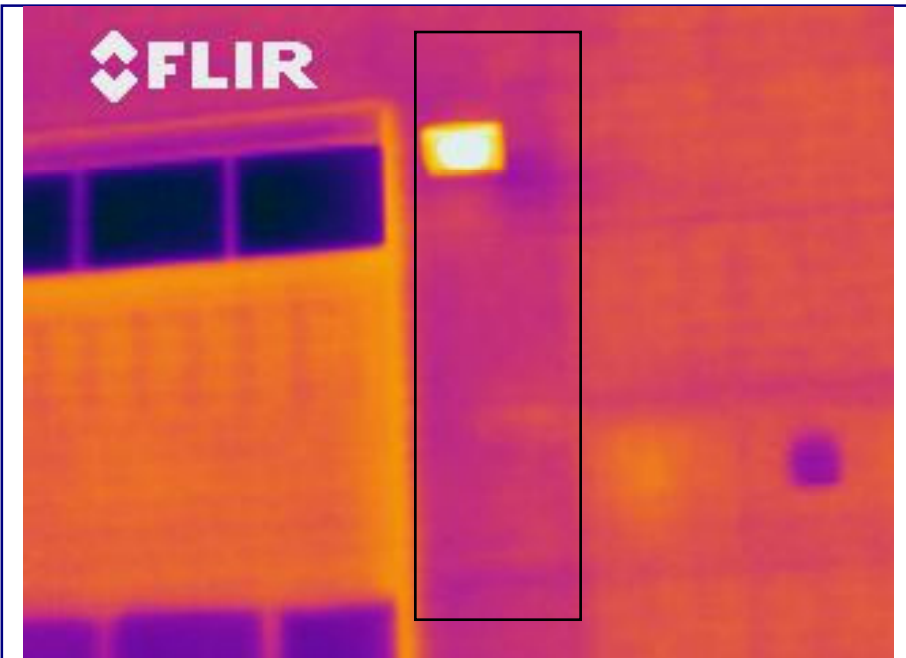
Picture 2

the purple is moderate moisture in the wall

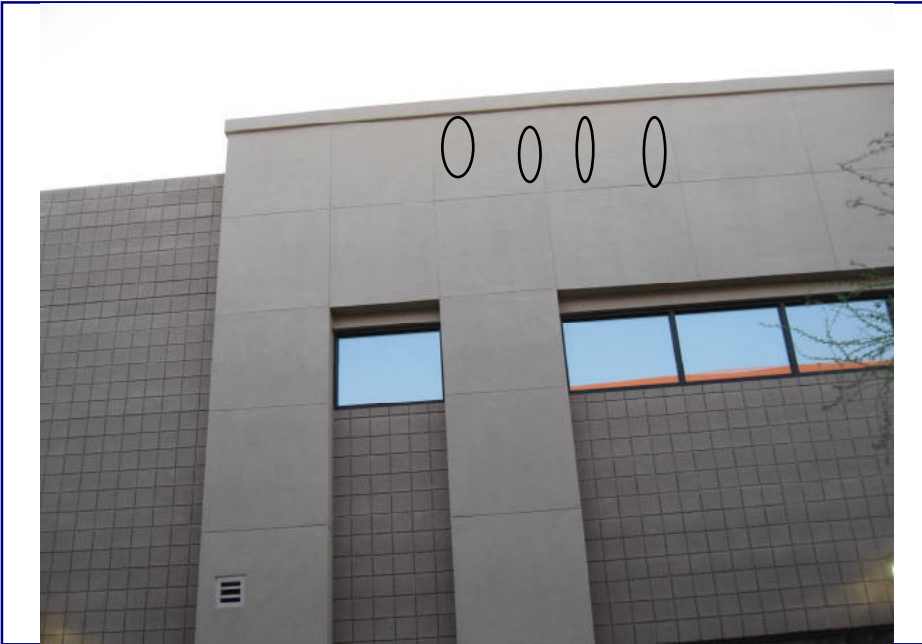
Picture 3

area over front doors

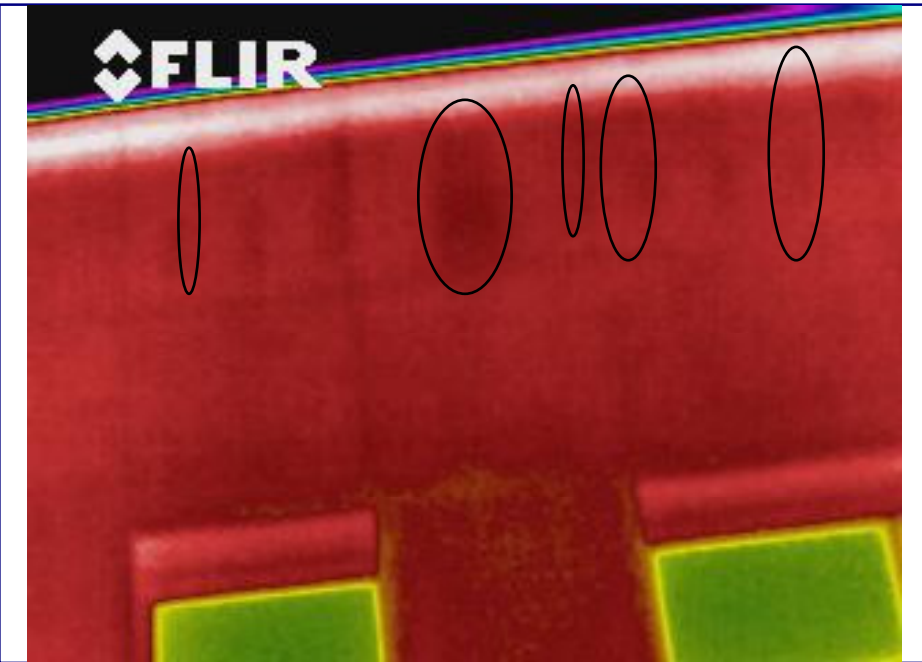
Picture 4

with a different palette the dark areas is moisture still in the stucco

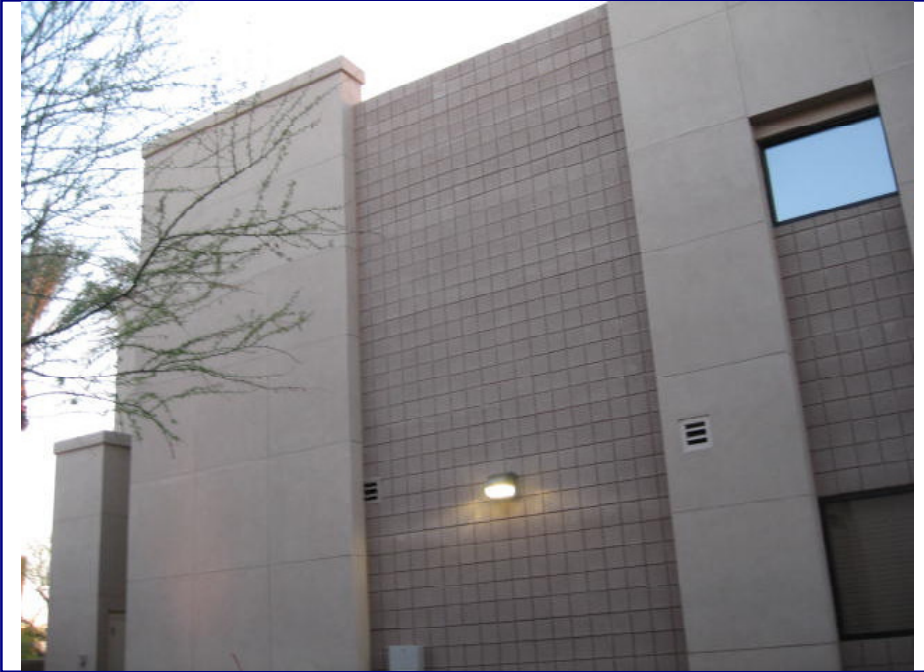
Picture 5

the corner of the building

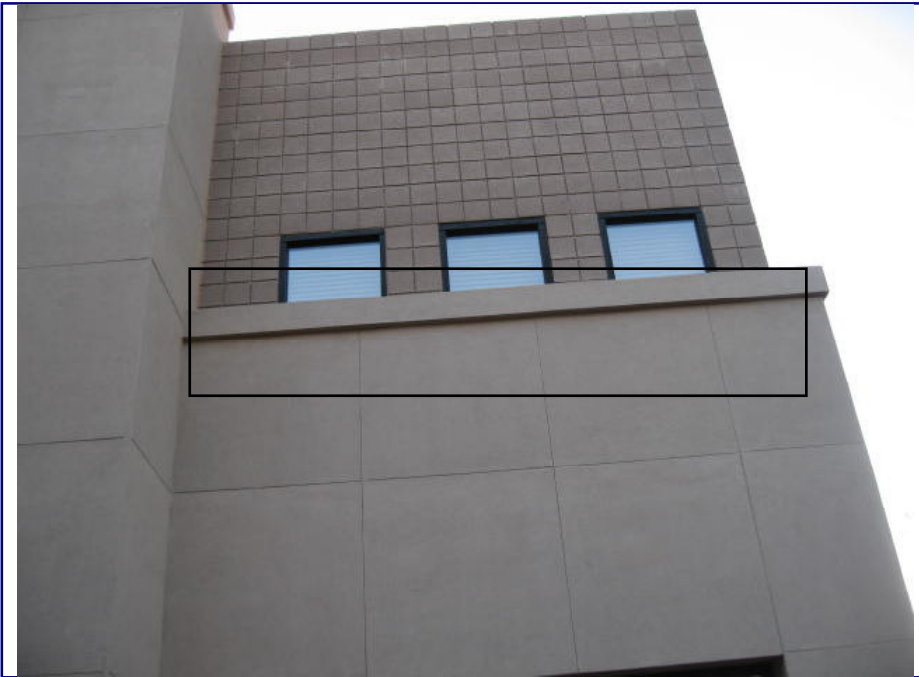
Picture 7

east wall north corner

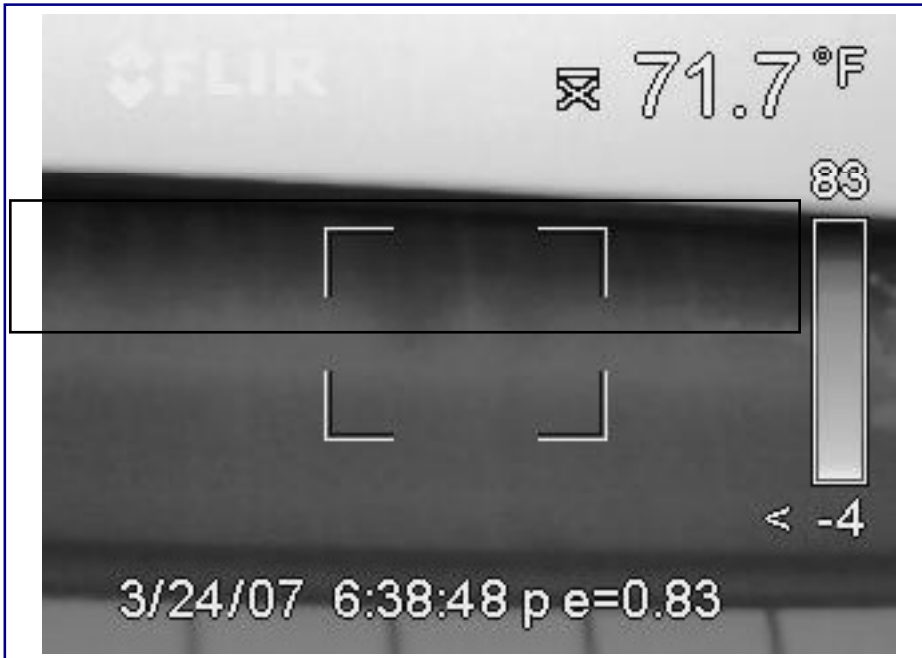
Picture 8

the top of the parapet has moisture wicking down the block (note the black is moisture.)

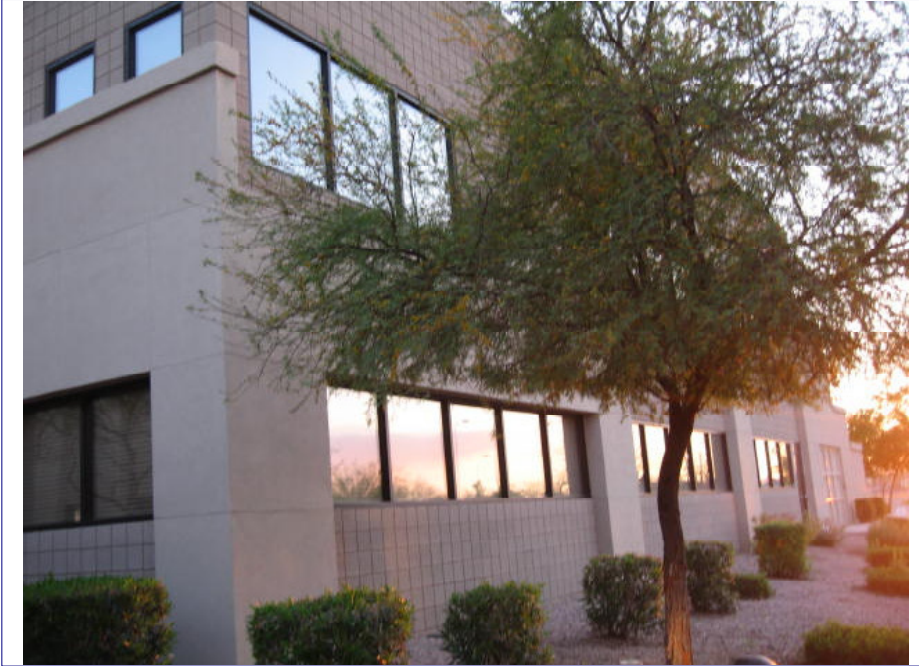
Picture 9

this is the north west corner.

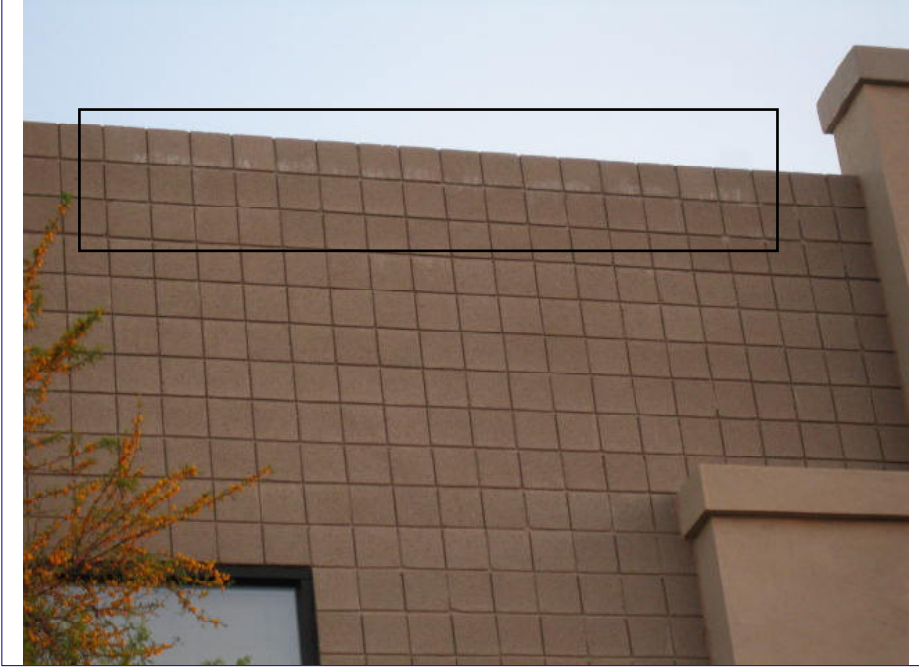
Picture 11

west facing wall . note the efflorescence at the top of the wall that is more moisture wicking its way down through the wall

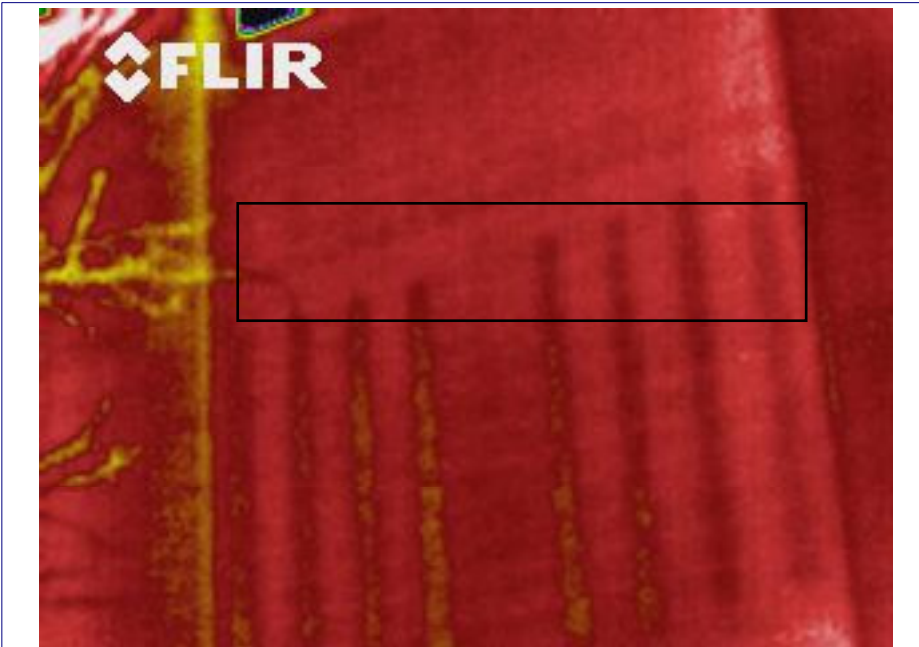
Picture 12

the dark and yellow vertical lines are the pilasters that stop at second floor

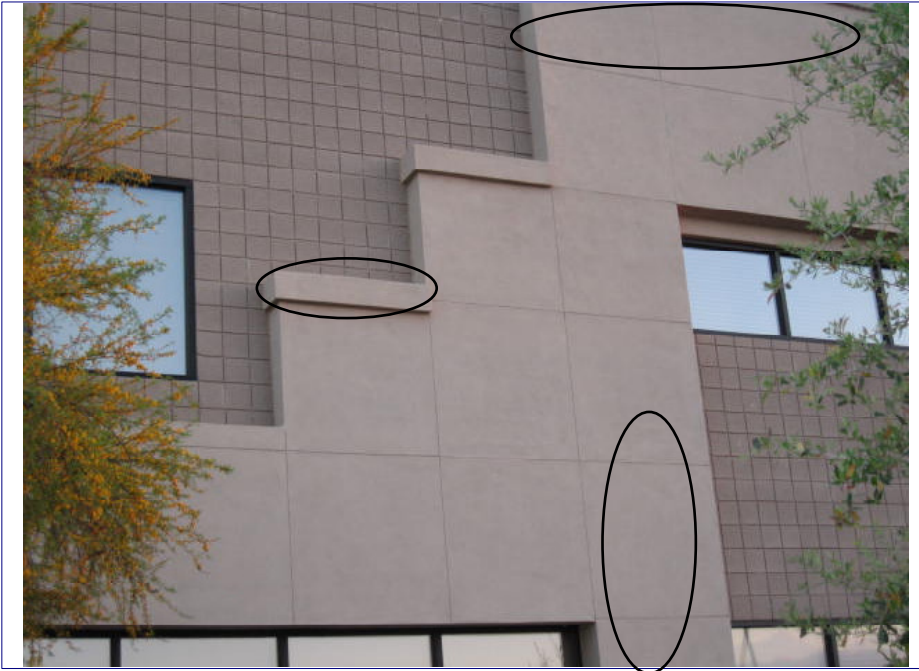
Picture 13

west side by the corner

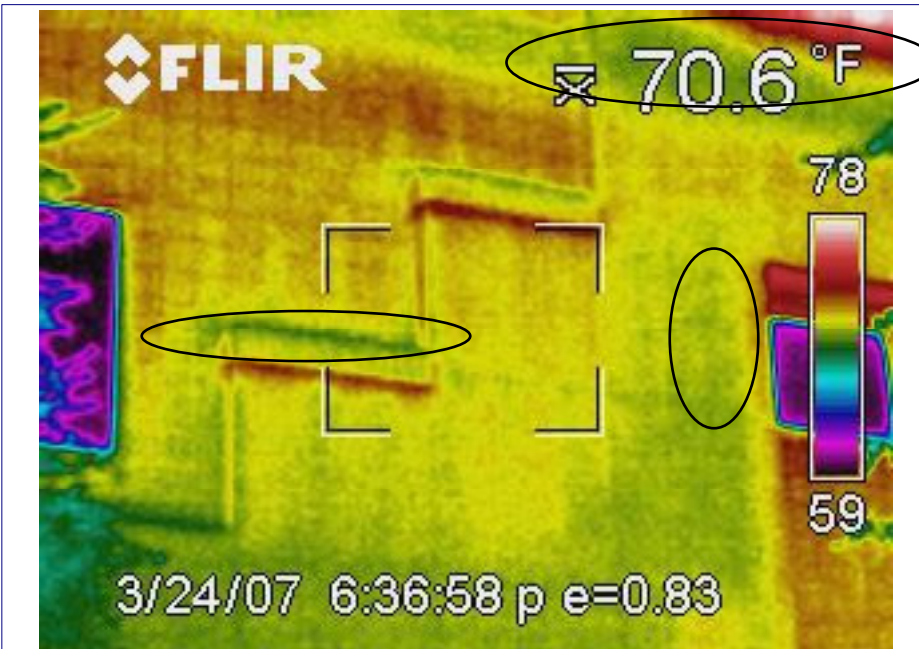
Picture 14

the green horizontal lines is moisture in the EFIS.
The upper corner of the picture is green moisture at the parapet

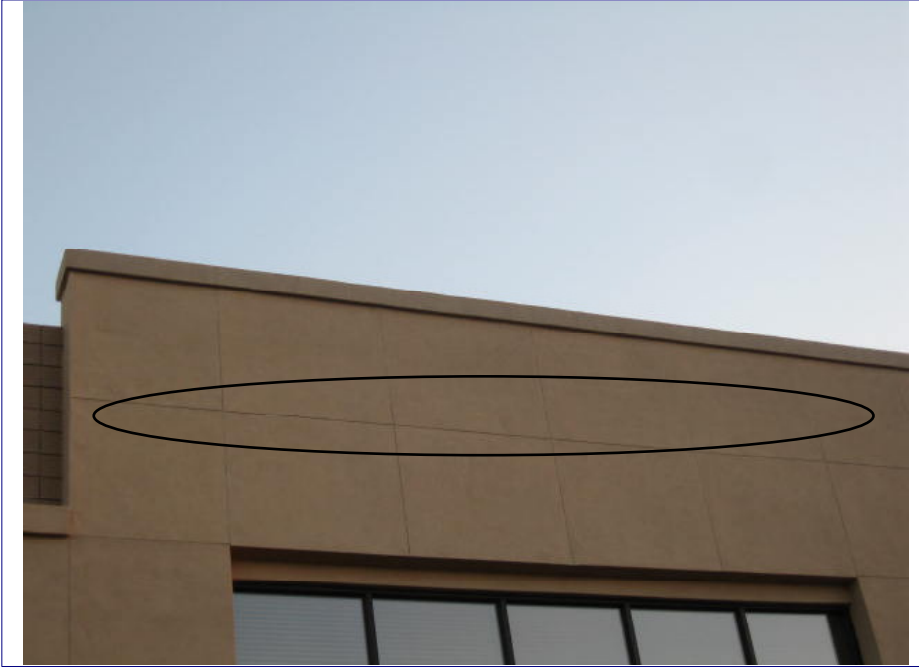
Picture 15

top shot of the building

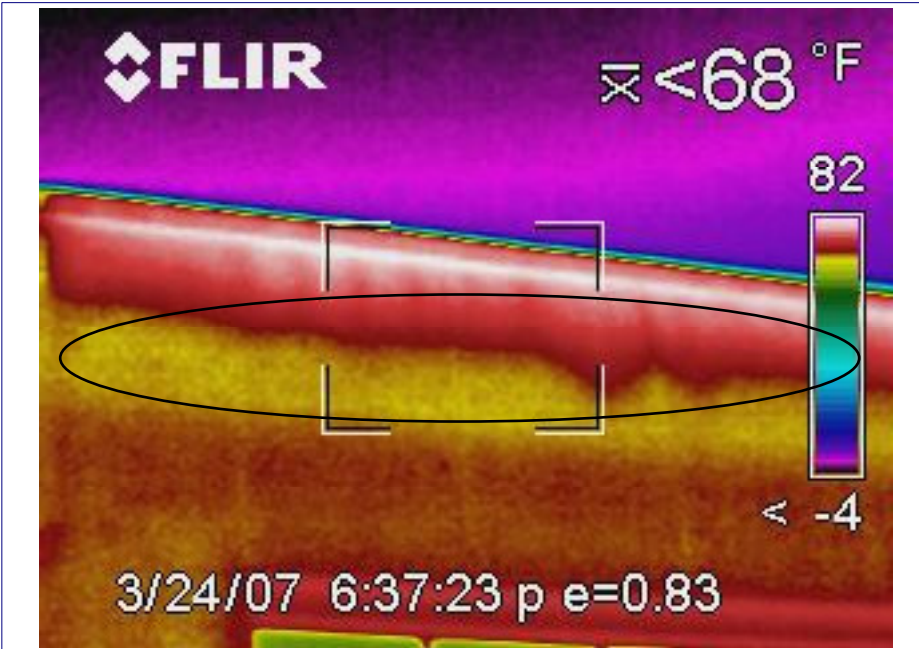
Picture 16

the lack line below the red is the depth that the moisture has worked its way down

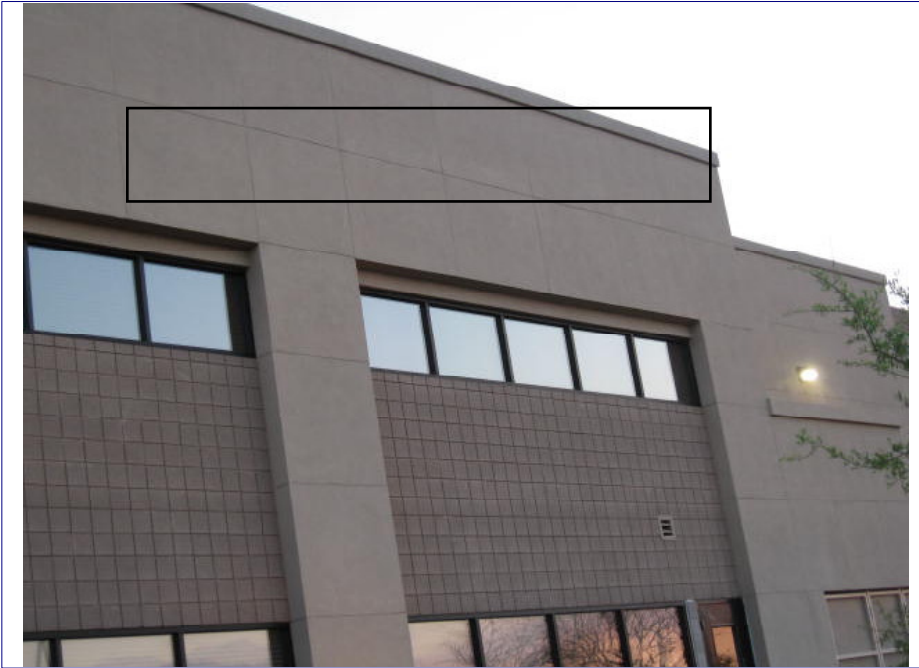
Picture 17

south side view

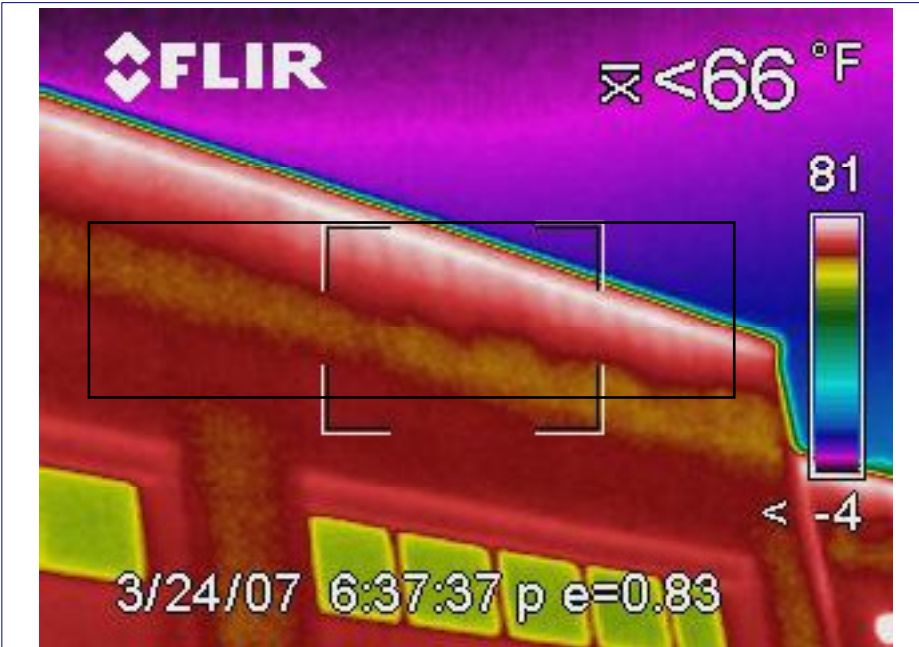
Picture 18

the yellow is the level that moisture has migrated.

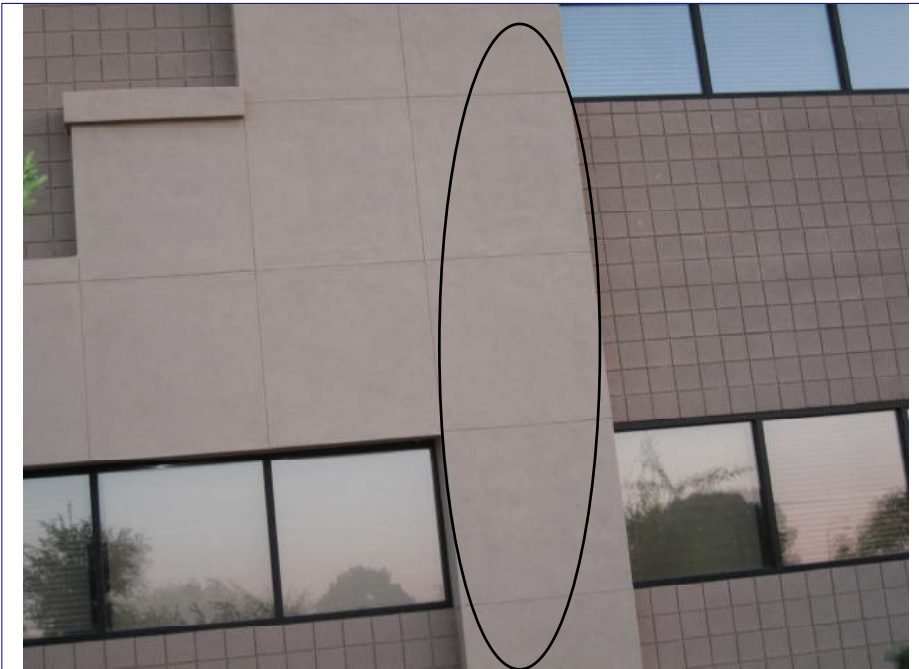
Picture 19

more south side

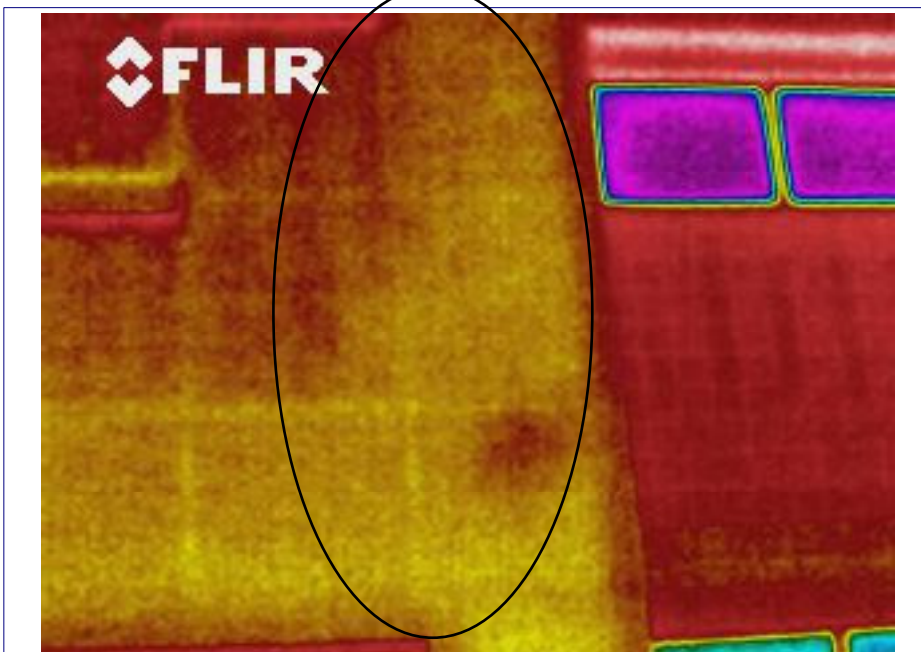
Picture 20

the yellow is retaining moisture

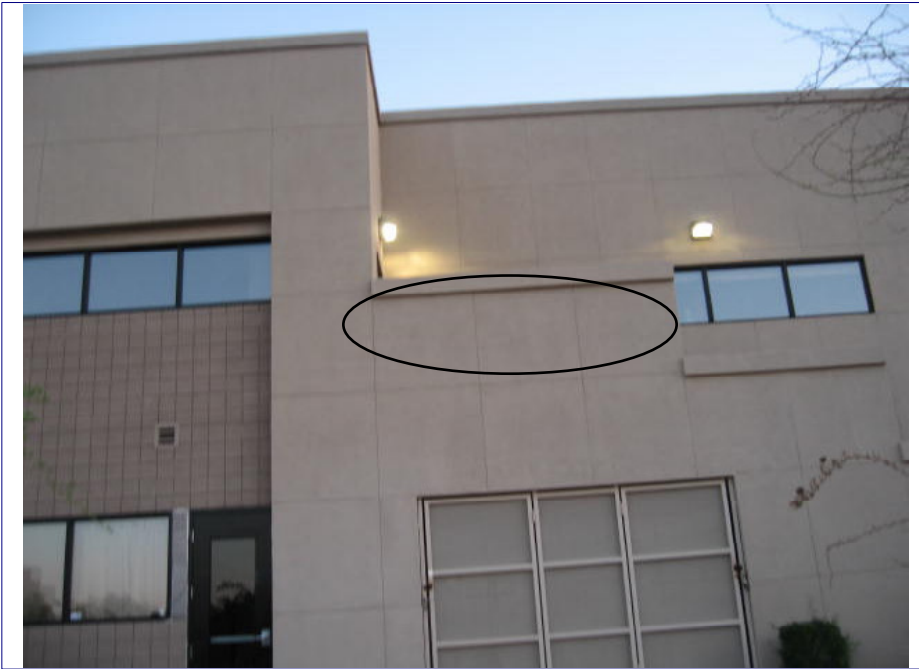
Picture 21

the transformer enclosure area

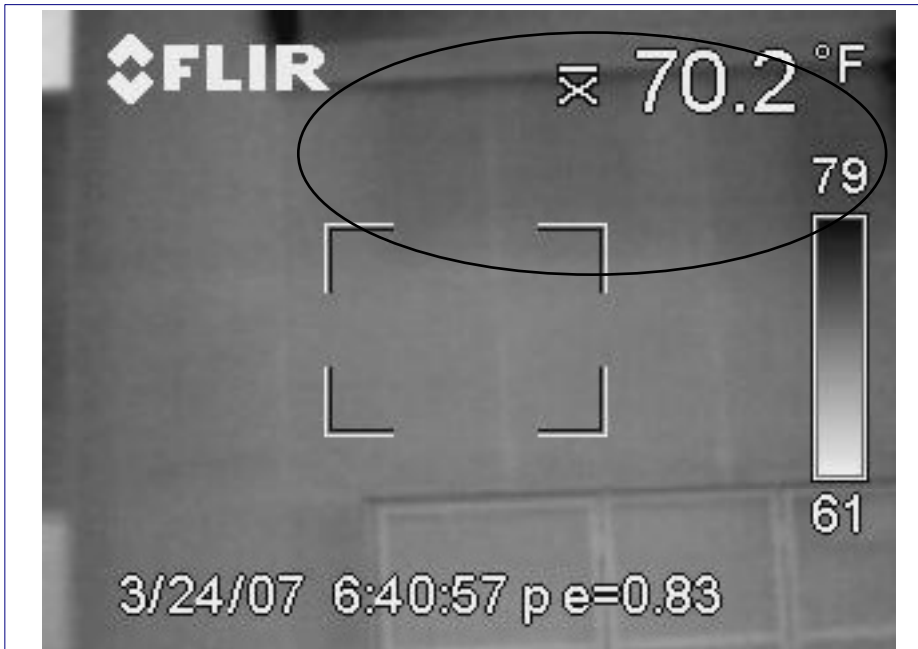
Picture 22

changing pallets , the dark area are moisture build up.

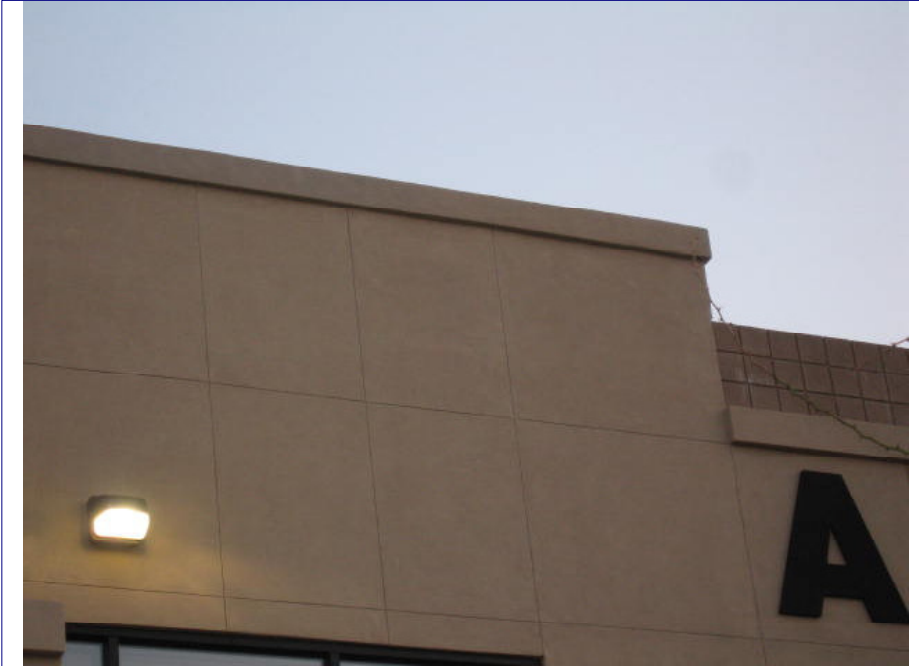
Picture 23

corner of the building

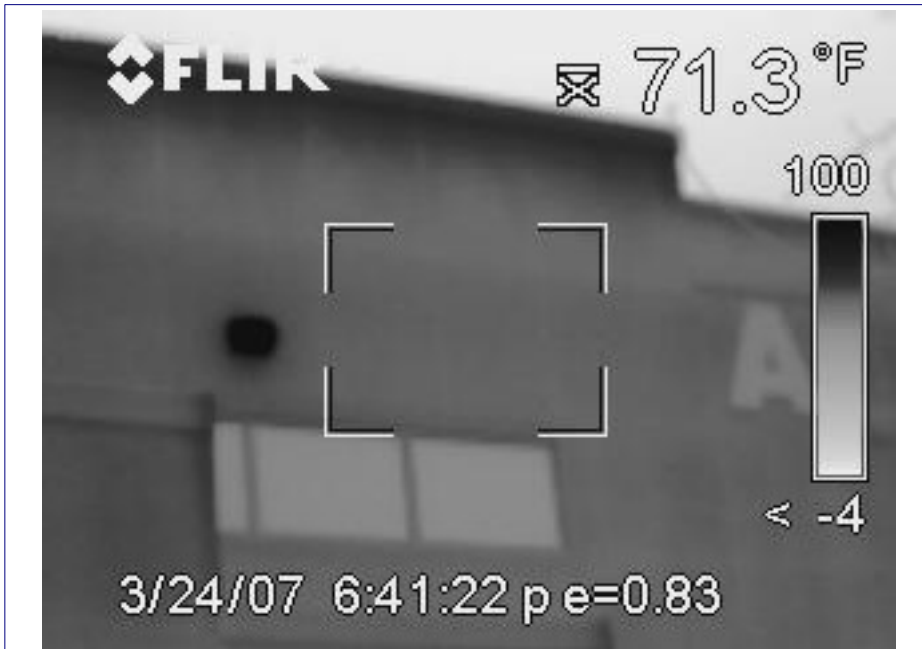
Picture 24

the dark areas is standing moisture

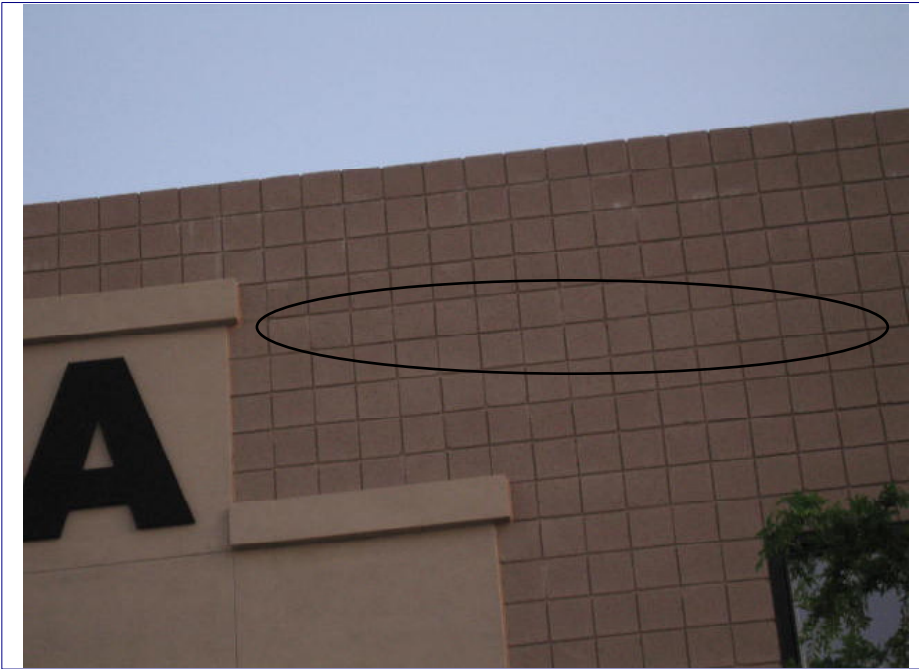
Picture 25

opposite side of corner shot

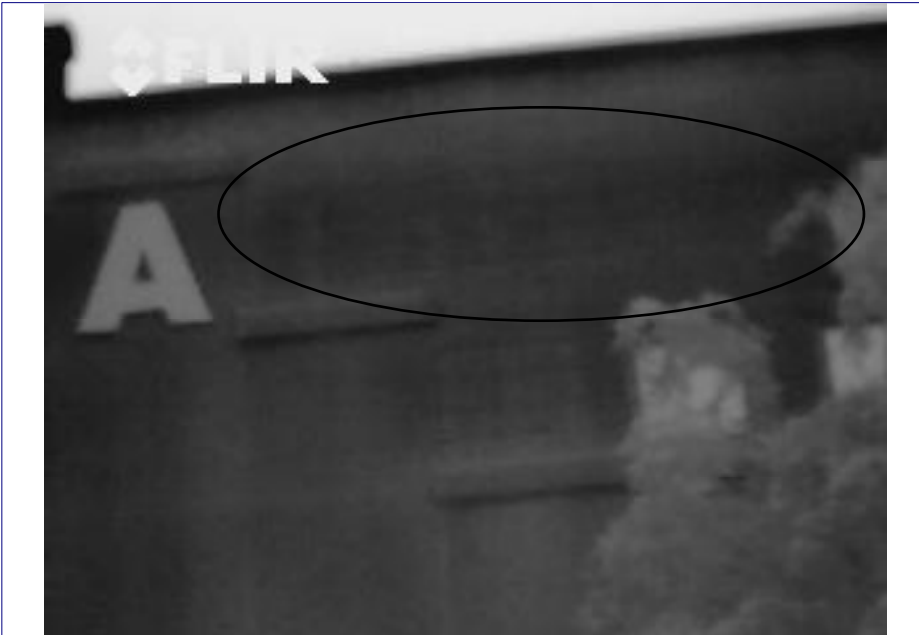
Picture 26

changing the palette reverse
white is moisture, except the A
that is heat (the color black in
infrared always reads as
100%)

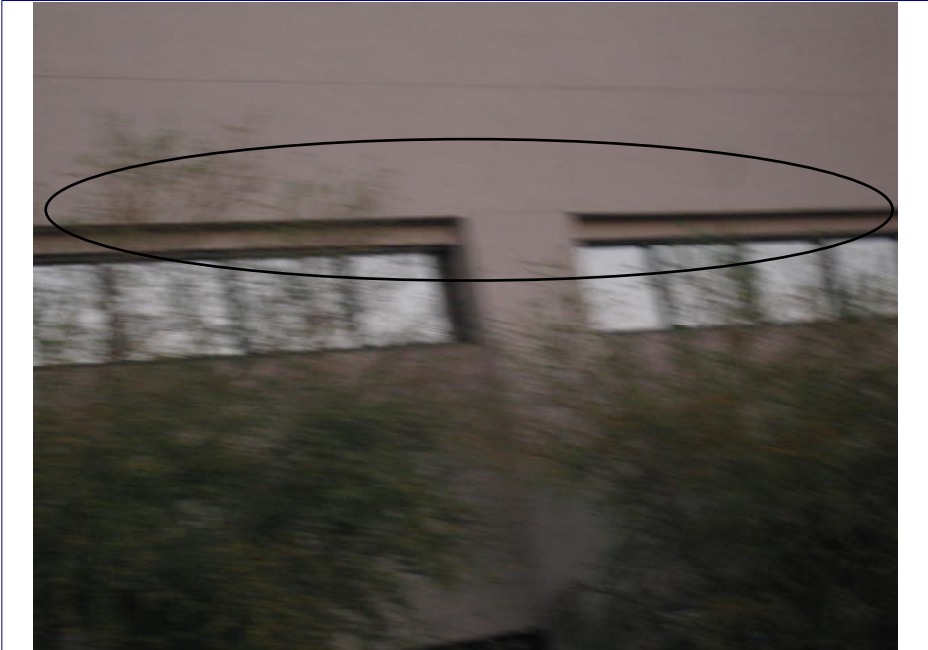
Picture 27

over th windows

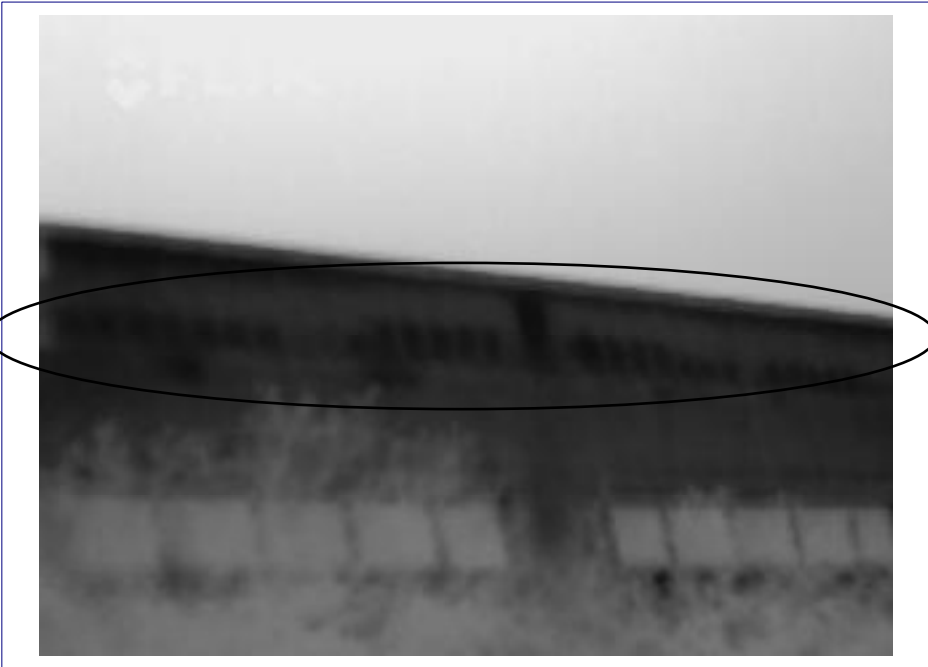
Picture 28

the light areas are moisture areas

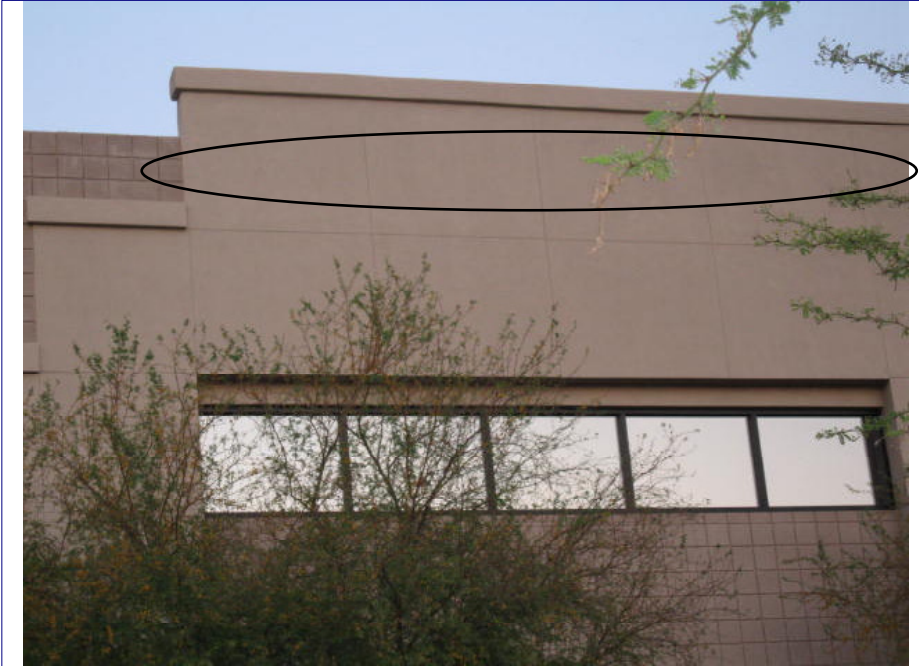
Picture 29

south side

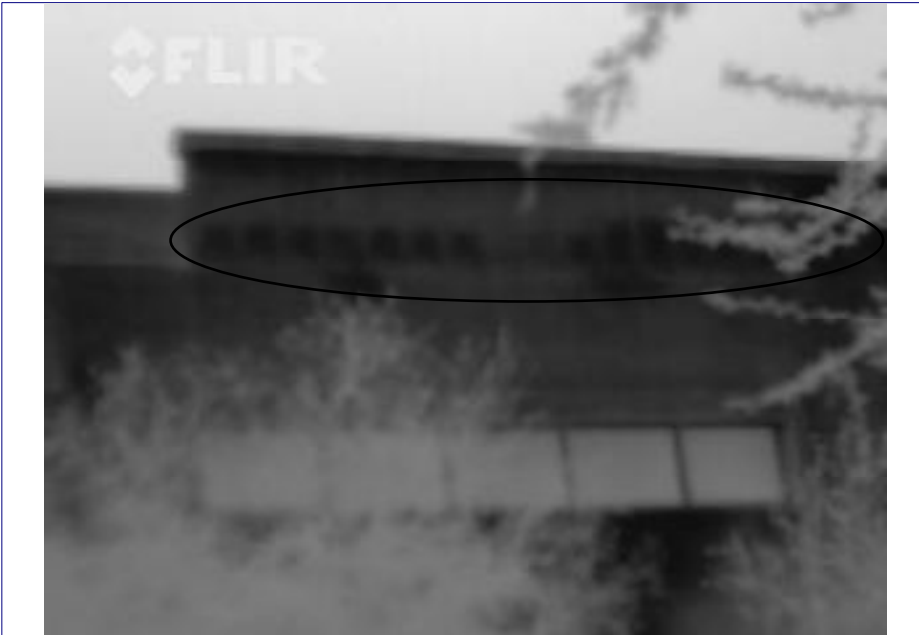
Picture 30

note the dark squares below the roof line , more pockets of moisture.

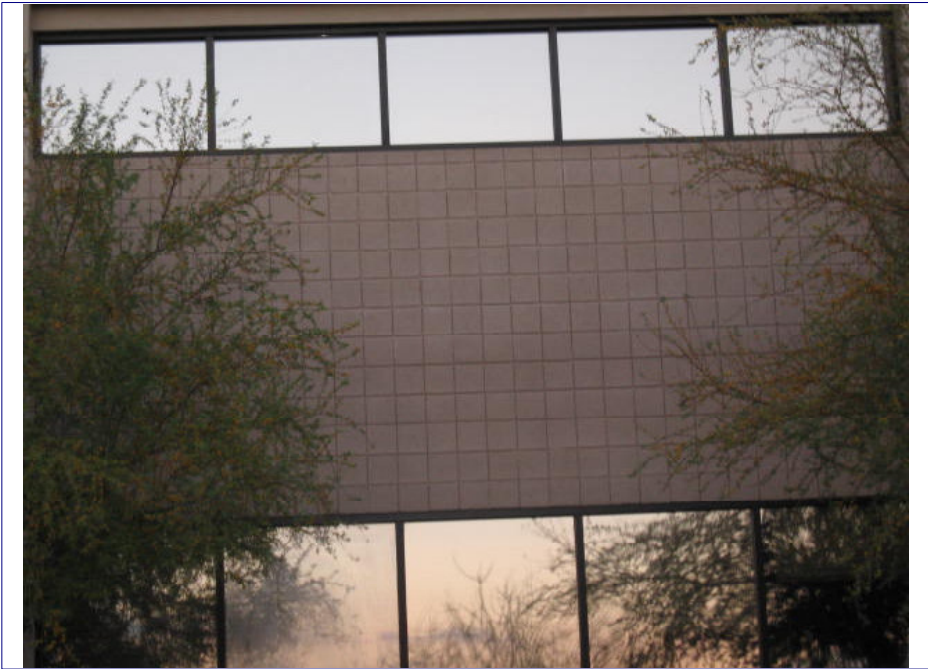
Picture 31

above the fogged windows.

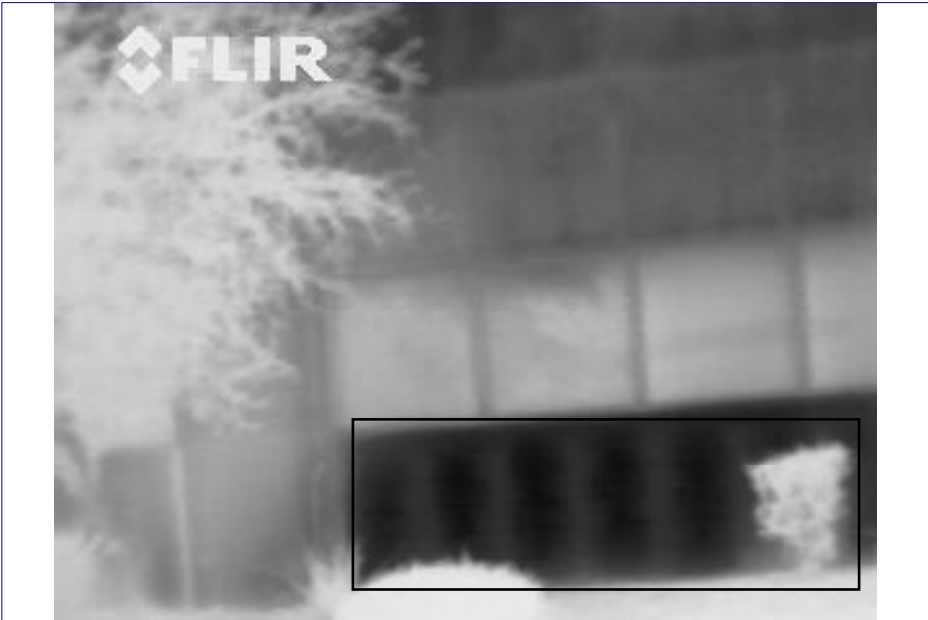
Picture 32

clear above windows but
moisture below them.

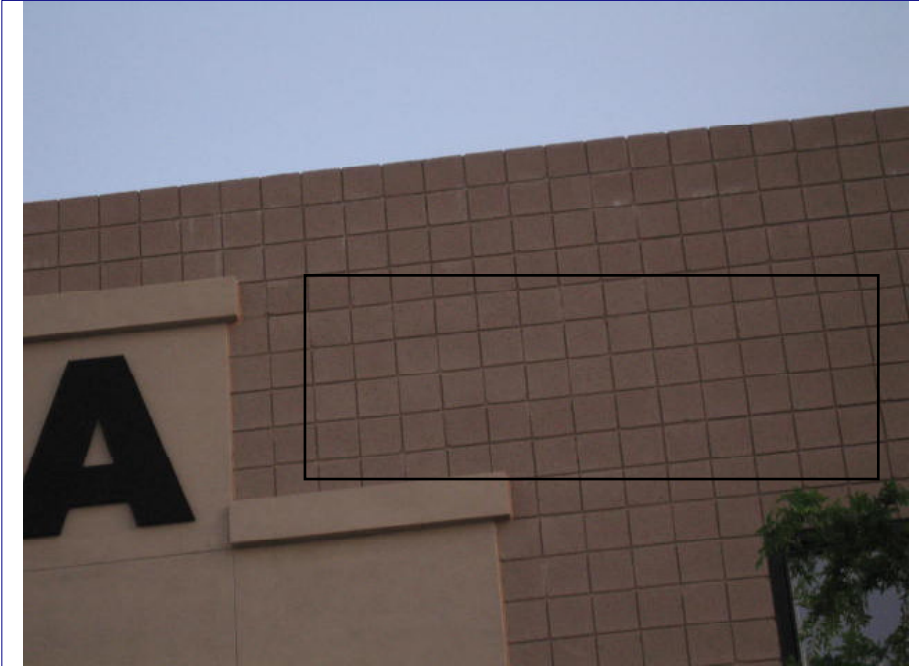
Picture 35

second view of corner of building

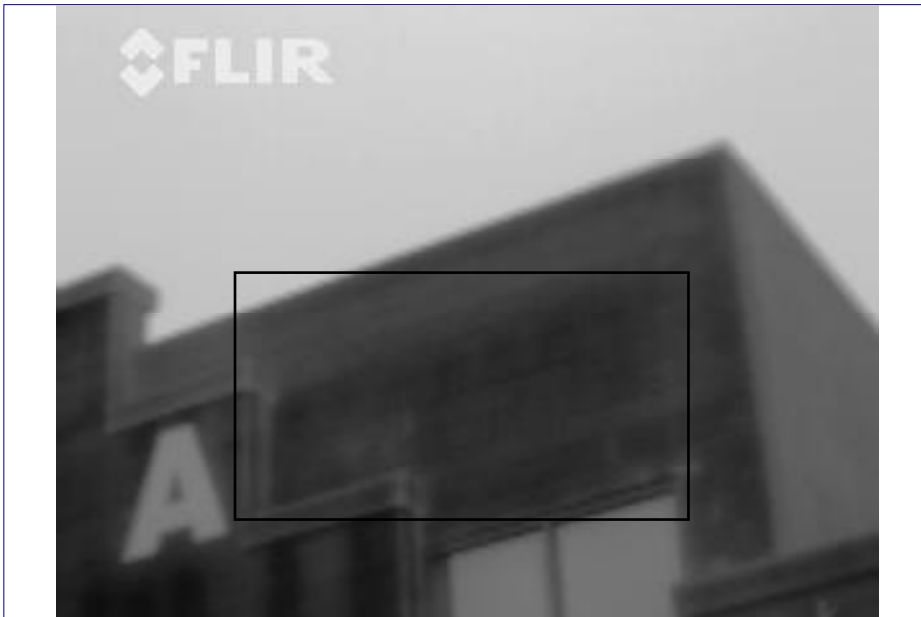
Picture 36

Description
latent moisture in the wall
(dark areas)
