PROPERTY CONDITION ASSESSMENT

655 E Dobson Rd, Chandler, AZ,

3/13/2007 from 11:36 AM to 5:36 PM

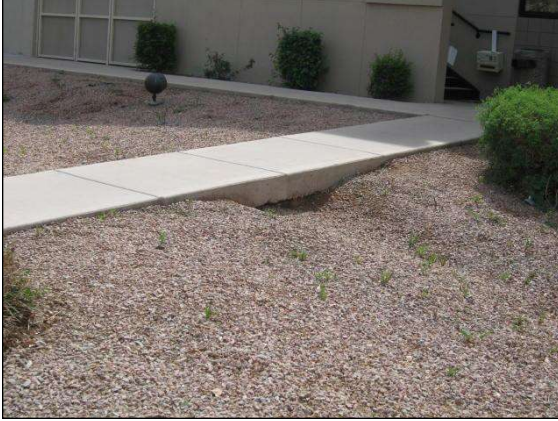
Figure 1: drain not working

The site is served by area drains that appear to be in acceptable condition. However, because it is impossible to see inside them, the seller should guarantee that the drains are functional, or they should be flushed through to the street or other discharge points. This is important, because surface water carries silt and debris that is deposited inside the pipes and can harden in the summer months to the consistency of wet concrete, which can impede drainage and require the pipes to be cleared by a roofer service.

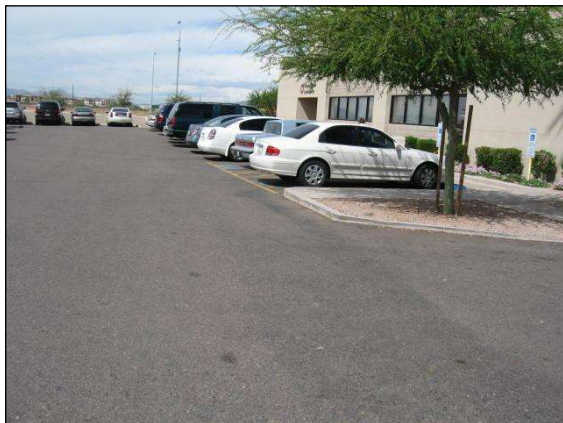
Based on occupancy status, the parking space may not be inadequate.

Figure 1: very few ADA parking spaces

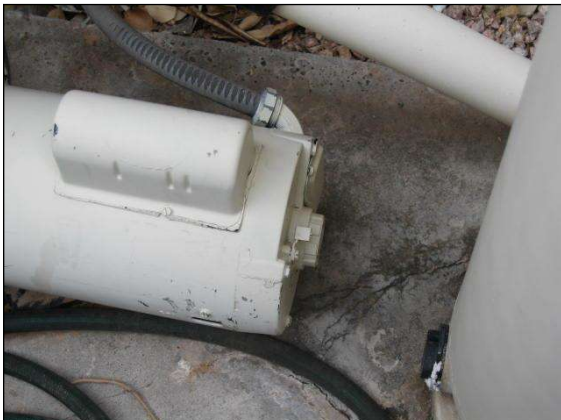
The pump motor needs its body bond at which a lug has been provided to keep the public from being shocked needs a bare bond line installed.

Figure 1: fountain motor missing safety bond

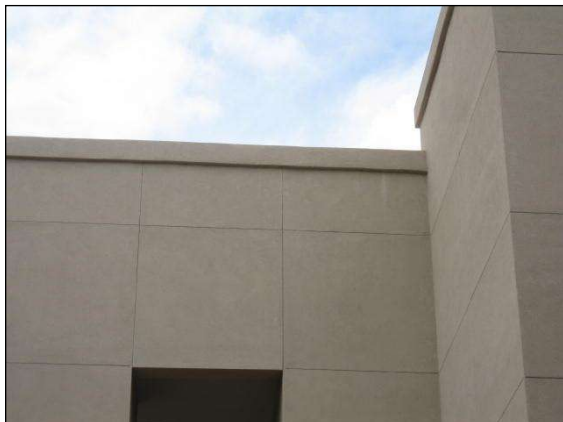
The building walls appear to be finished with a synthetic stucco, also known by the acronym EIFS, or Exterior Insulation and Finish Systems, which has been subject to litigation for alleged defects. This type of wall finish was intended to be impervious to moisture and therefore had no provision for drainage, such as the weep-screed on conventional stucco installations. However, if moisture does penetrate through breaks or inadequately caulked seams around windows and doors it remains trapped within the walls where it can deteriorate the framing and other materials. Therefore, we recommend that the walls be evaluated by a specialist employing moisture detection or thermal imaging equipment.

Figure 1: EFIS is known for moisture problems

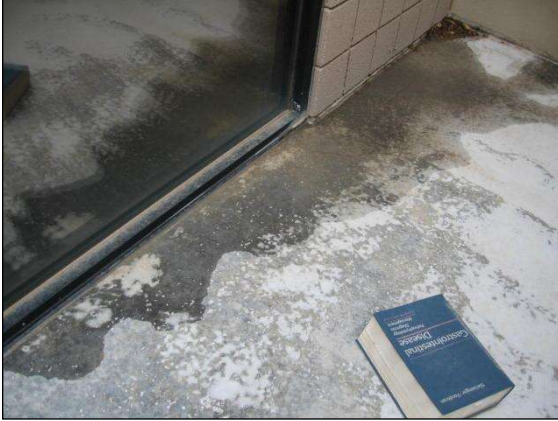
Figure 1: improper slope and water intrusion at master suite balcony has been on going problem.

There is evidence of moisture contamination below the balcony surface, possibly indicating that the waterproof membrane beneath the balcony surface has failed, and should be evaluated by a specialist. (off of the owners suite)

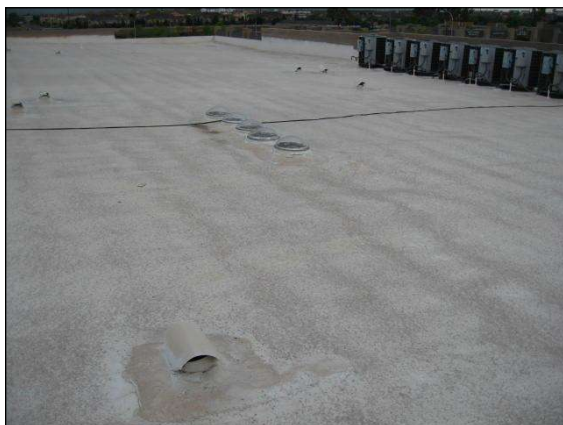
Figure 1: the foam roof has had maintenance done and needs to continue.

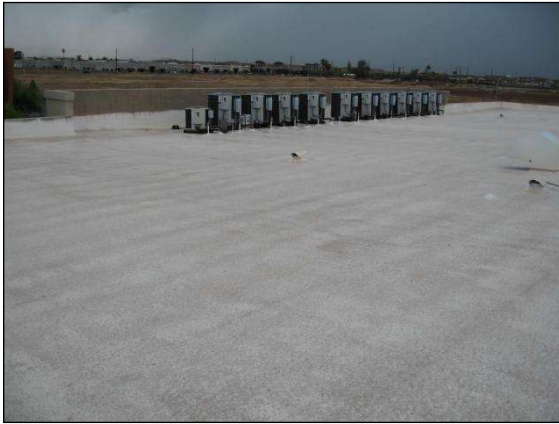
The tops of the parapet walls are not adequately sealed, which could allow moisture to penetrate.

Figure 1: the cmu blocks to the left of the compressors are not capped/ flashed.

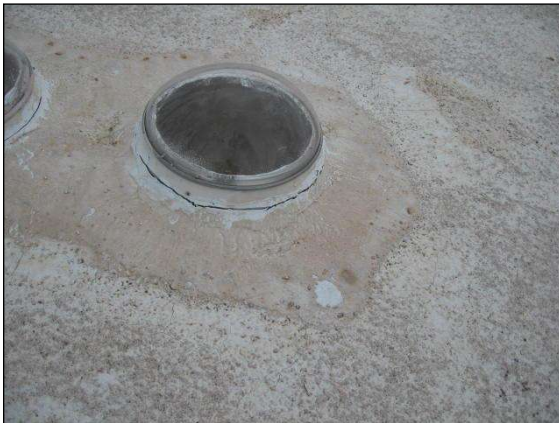
Figure 1: open seams at sky lights need repair

The edges of the skylight have been coated with tar or mastic. This is unconventional, indicative of an amateur installation, or confirmation of a leak. Regardless, tar and mastic do not provide an adequate or permanent seal. Consequently, the skylight could leak and should be monitored or removed and serviced correctly.

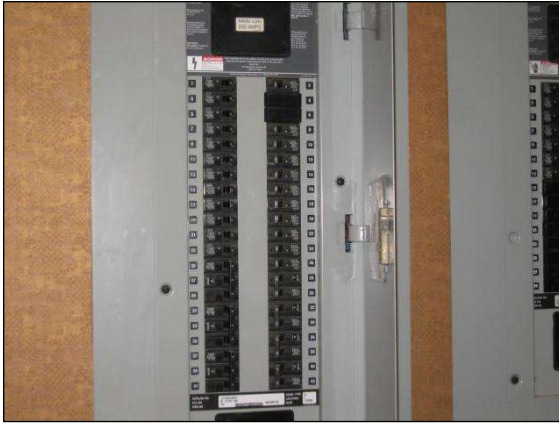
the infrared review of the sampling of panels indicates a need for panel maintenance to be done to keep up with the load demand in the various offices.

Figure 1: over heated breakers needing maintenance(need system checked for loose connections)

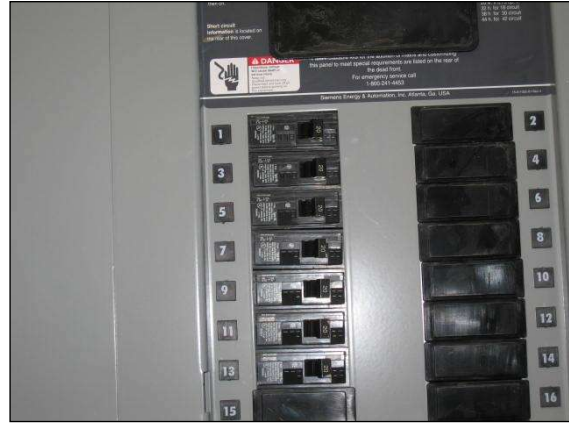
Figure 2: breakers in this panel were showing excessive heat signatures

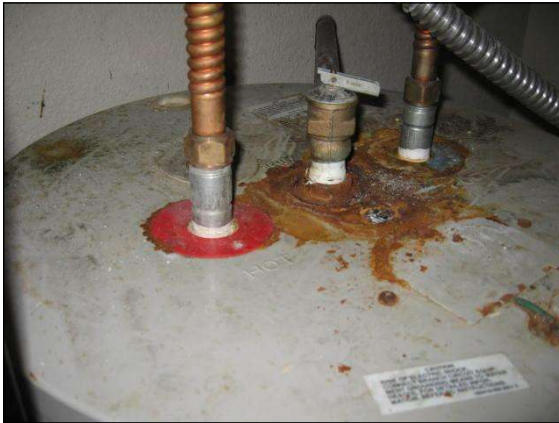
Figure 1: unit at end of useful life corroded at tank body

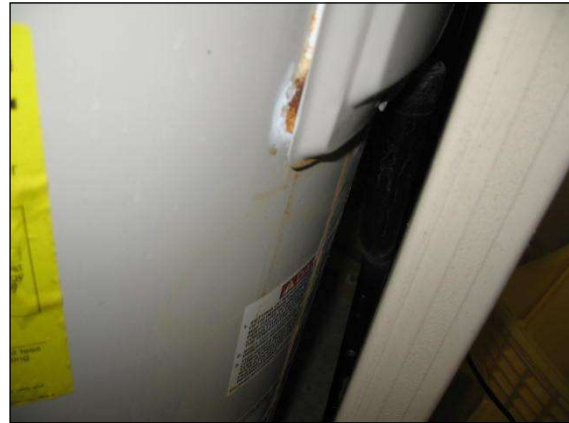
Figure 2: same unit as above at second floor suite and needs replacement.(before damage to other offices from water leaks)

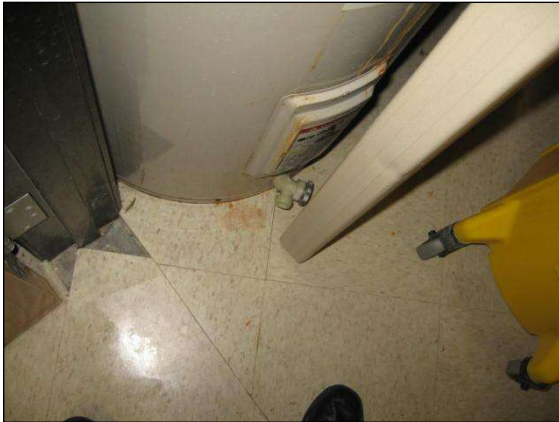
The water heater is not equipped with a drip-pan or overflow pipe, which is recommended and designed to minimize water damage from a leak.

Figure 1: water heaters in all the suites lack a catch pan with a pipe draining to the floor drain

2. Recommend that each suite maintain its own water hearwes and protect the building from water damage issues by installing catch pans .

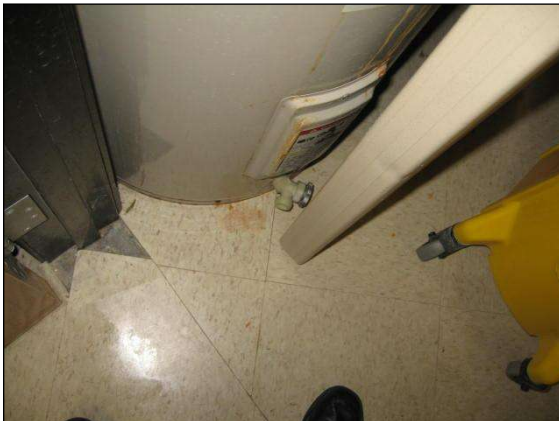
Figure 1: rust on unit clean out valve appears to be in working status.

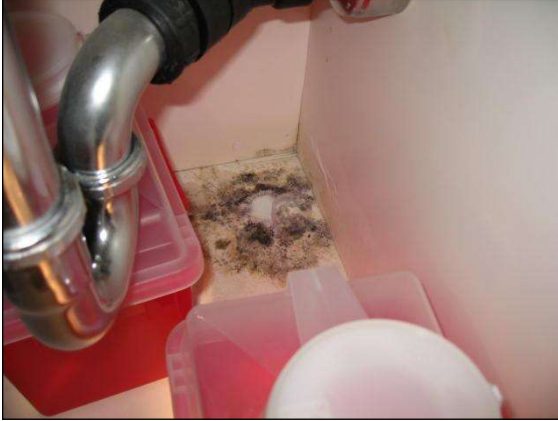
We have detected a mold-like substance within the middle which should be evaluated by a mold specialist or environmental hygienist. However, you can learn more about mold office and bathrooms from a document issued by the Environmental Protection Agency entitled "A Brief Guide to Mold, Moisture and Your Home, by visiting their web site at <http://www.epa.gov/iaq/molds/moldguide.html/>, which can be downloaded.

Figure 1: mold/ mildew neds to be cleaned up

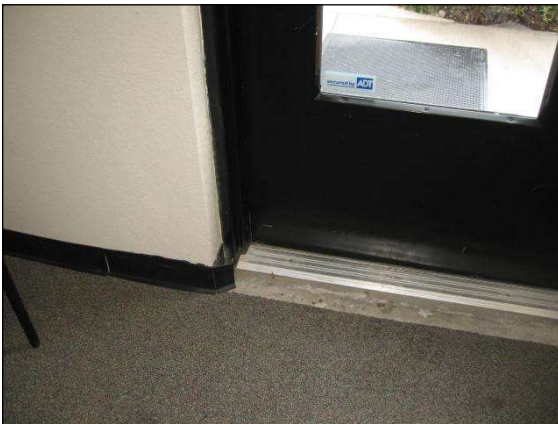
the door threshold rub, water flows through seal, door difficult to operate and needs repair.(1st floor south , 1st floor and ,2nd floor balcony private patio north)(has standing water).

Figure 1: door binds at threshold and needs frame repaired.

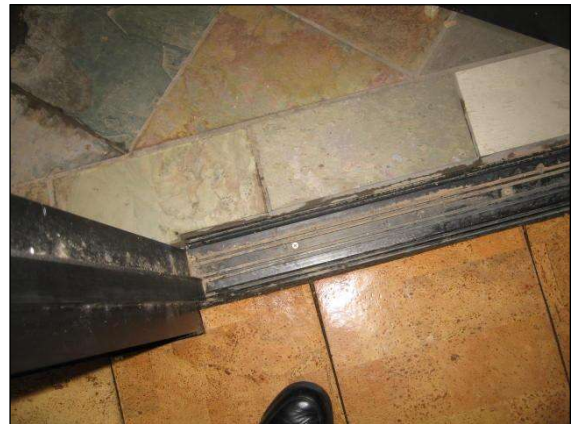
Figure 2: moisture was flowing through threshold plate prior to mopping

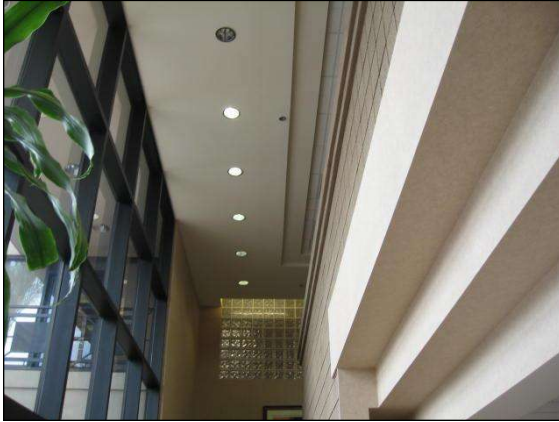
Figure 1: entry lobby (note light not working)

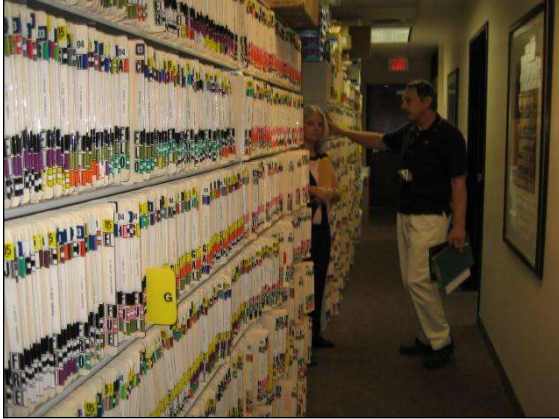
Load bearing capacity needs to be evaluated for the amount of files being stored on the second floor.

Figure 1: Has file system been figured into the floors dead load bearing capacity?(second floor)

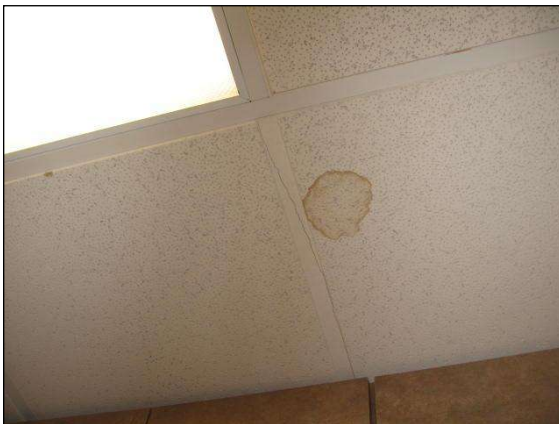
There is evidence of moisture intrusion that we will identify, but you should ask the sellers about this or have the condition evaluated by a grading and drainage contractor.

Figure 1: water stains at first floor (a/c line leak?)

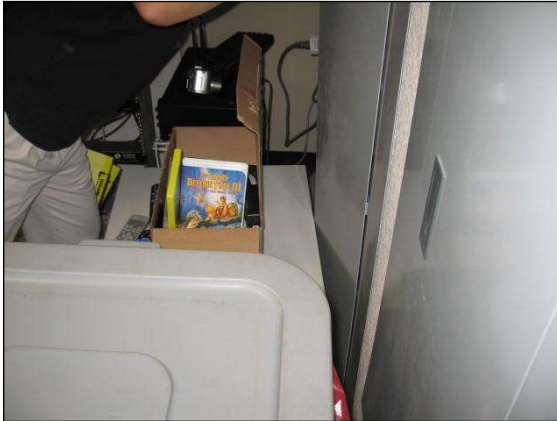
We have evaluated the utility room, and found it to be in unacceptable condition.(sub panels blocked with office supplies)

Figure 1: sub panels blocked for access at utility room/ fire safety
