# Dual-View Thermal Imaging Report

17017 n 12th street

Prepared for: Mr & Mrs Pushee

Date: April 14 2010

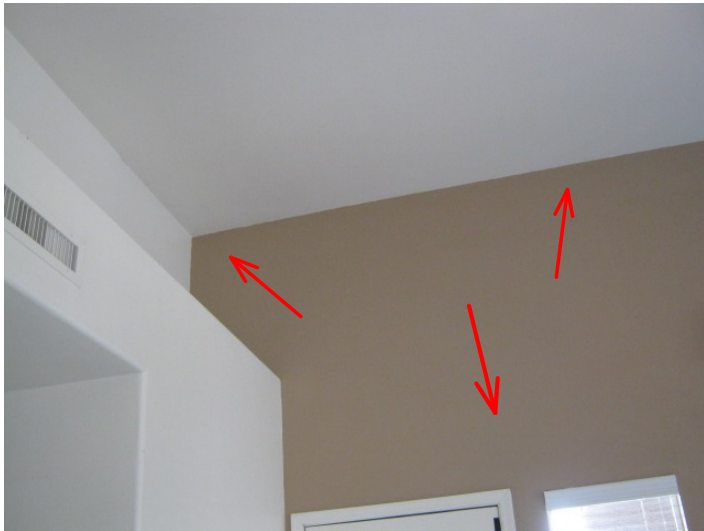
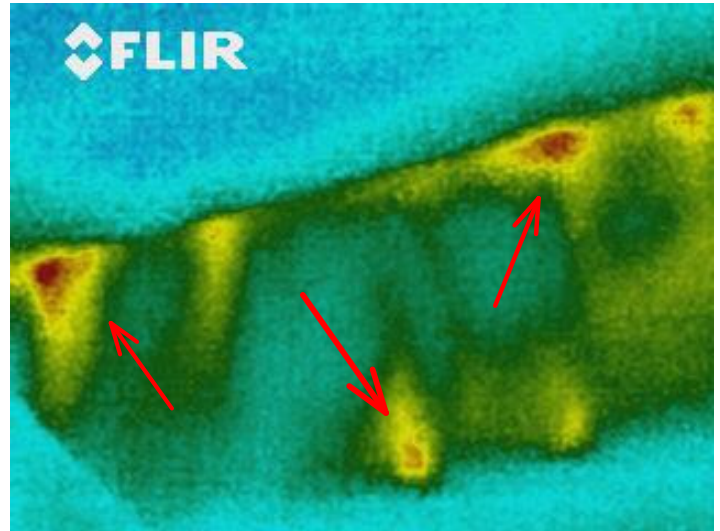
Location Floor: 2dn FLOOR  
 Location Room: LIVING ROOM OVER DOOR

**Observations:**  
 The red areas are gaps and voids in the wall allowing hot spots into the room.

Observations: The red areas are gaps and voids in the wall allowing hot spots into the room.

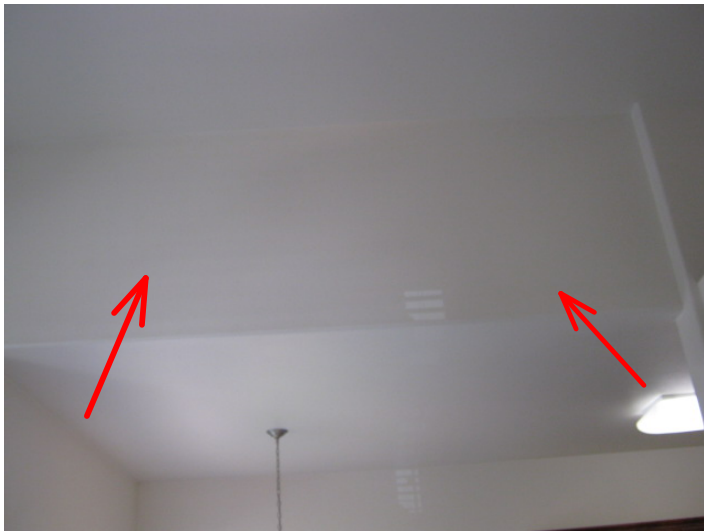
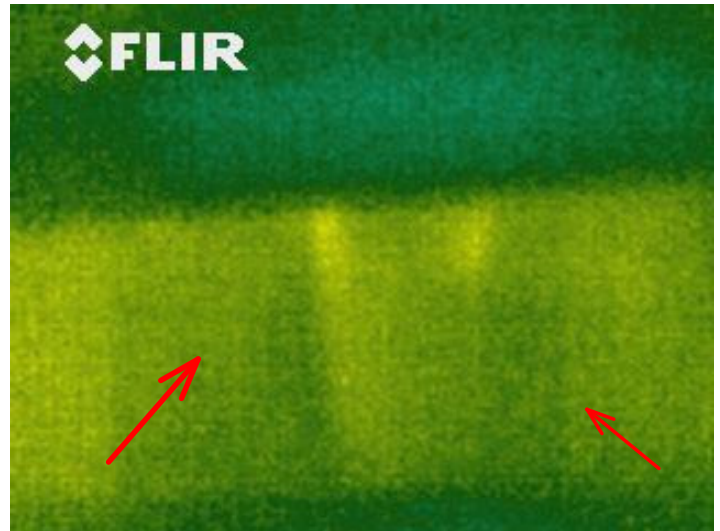
Location Floor: 2ND FLOOR  
 Location Room: LOOKING TOWARD DINNING ROOM

**Observations:**  
 The light yellow is wall/ ceiling withpor insulation whic is heating up the room.

Observations: The light yellow is wall/ ceiling withpor insulation whic is heating up the room.

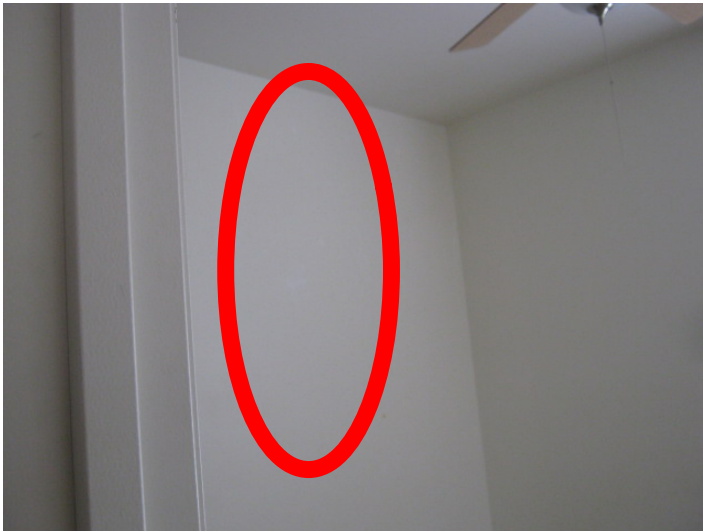
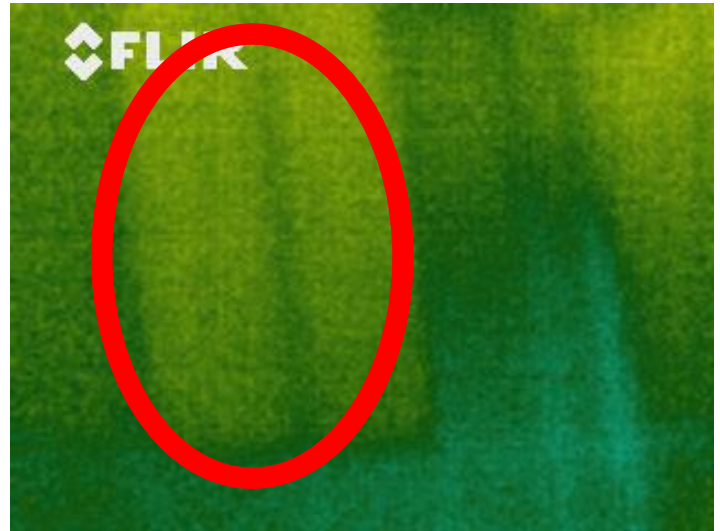
Location Floor: 2DN FLOOR  
 Location Room: LOOKING AT SOUTH BEDROOM WALL

The bedroom wall exposed to the exterior at the corner lacks proper insulation and will heat up the room. the yellow vertical squares are perfect out lines of how the batt insulation should be.

Observations: The bedroom wall exposed to the exterio at the corner lacks proper insulation and will heat up the room. the ywllow vertical squares are perfect out lines of how the batt insulation should be.

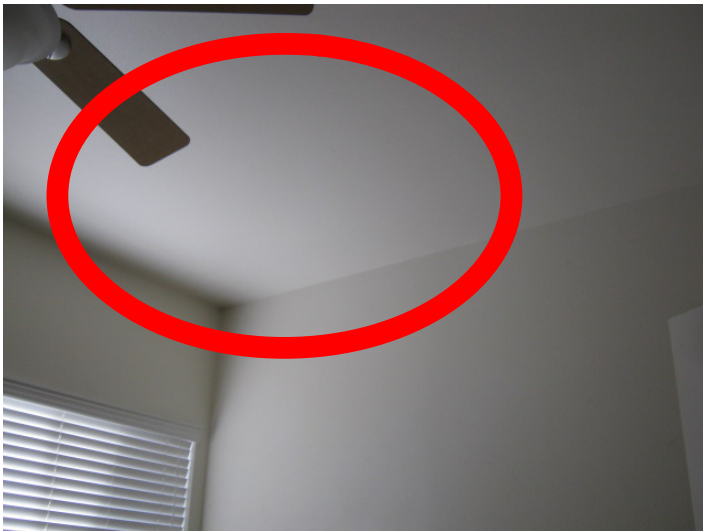
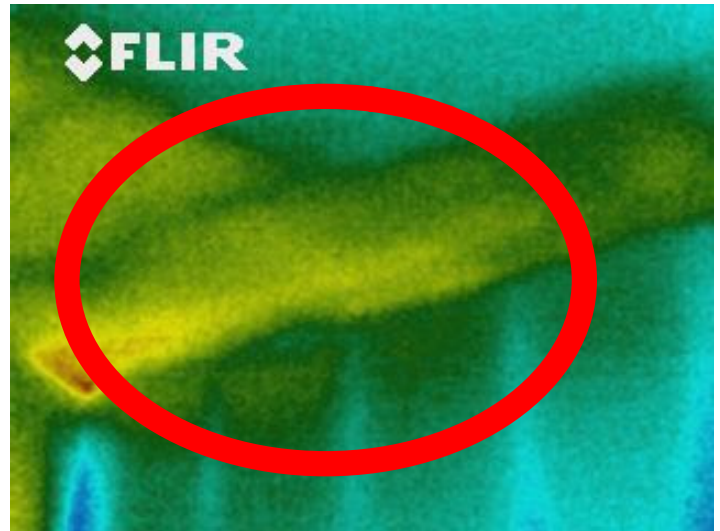
Location Floor: 2ND FLOOR  
 Location Room: BEDROOM CEILING

The yellow is the missing / poor insulation in the ceiling . The missing batts can be seen.

Observations: The yellow is the missing / poor insulation in the ceiling . The missing batts can be seen.

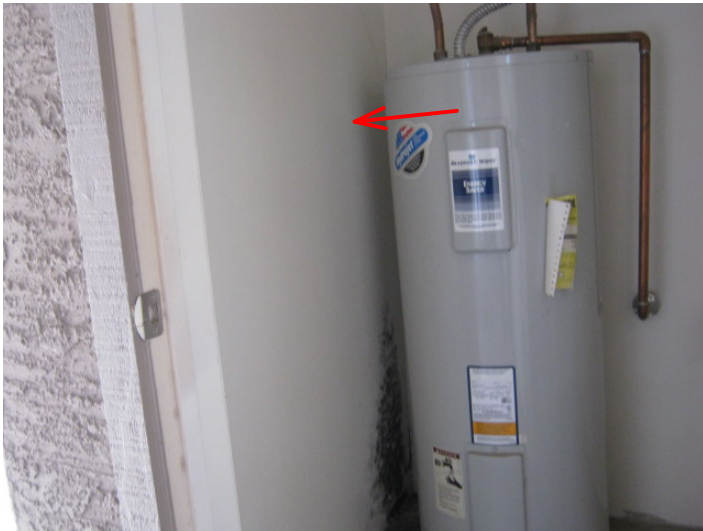
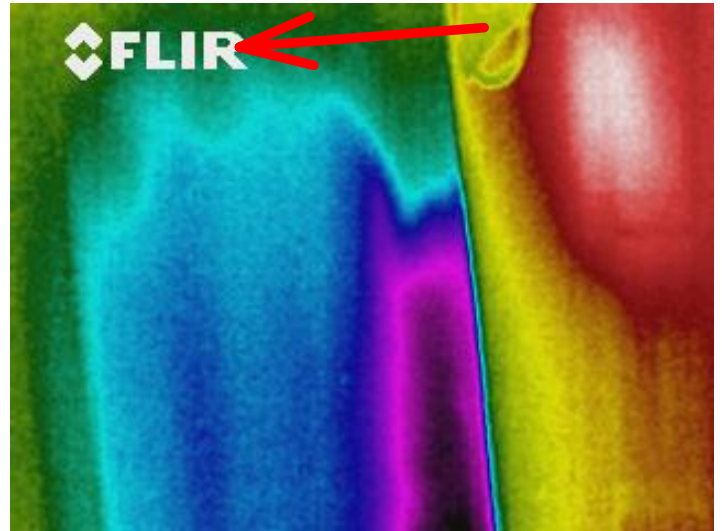
Location Floor: 2ND Floor  
Location Room: Storage closet;

**Observations:**  
The leve that the moisture has wicked up the wal can be seen , just above the round sticker

Observations: The leve that the moisture has wicked up the wal can be seen , just above the round sticker

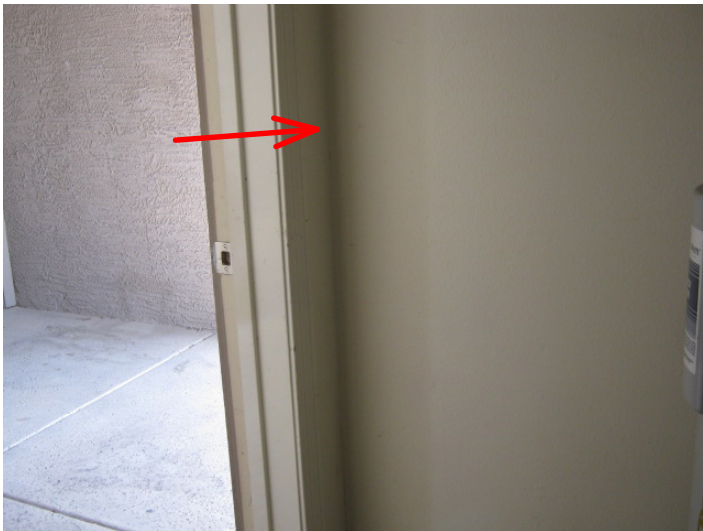
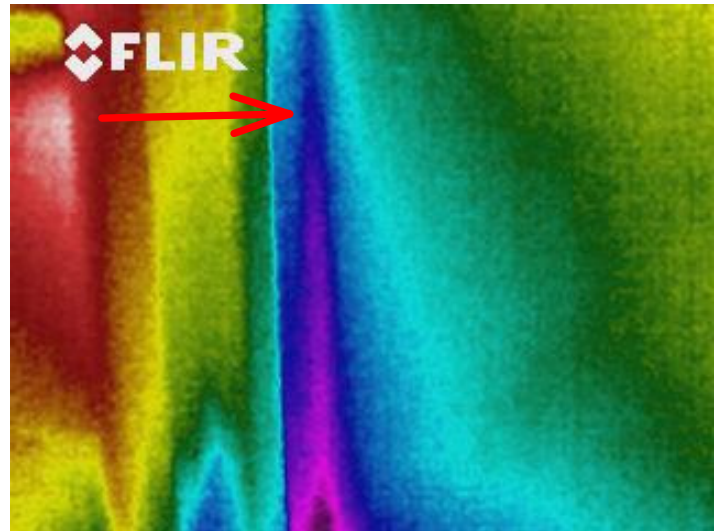
Location Floor: 2nd floor  
Location Room: Storage closet

**Observations:**  
the moisture has wicked up the door frame to just above the door stryker plate

Observations: the moisture has wicked up the door frame to just above the door stryker plate

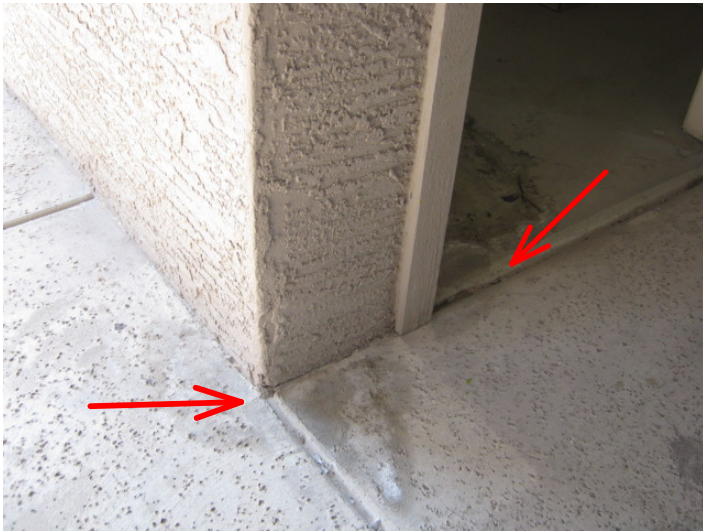
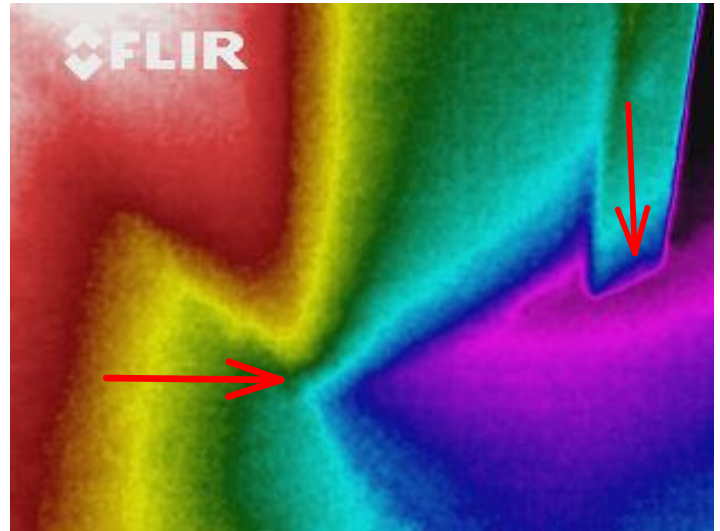
Location Floor: 2nd floor  
Location Room: exterior storage door

**Observations:**  
The moisture has permeated the concrete and has flow into the crack in the deck downward.

Observations: The moisture has permiated the concrete and has flowinto the crack in the deck downward.

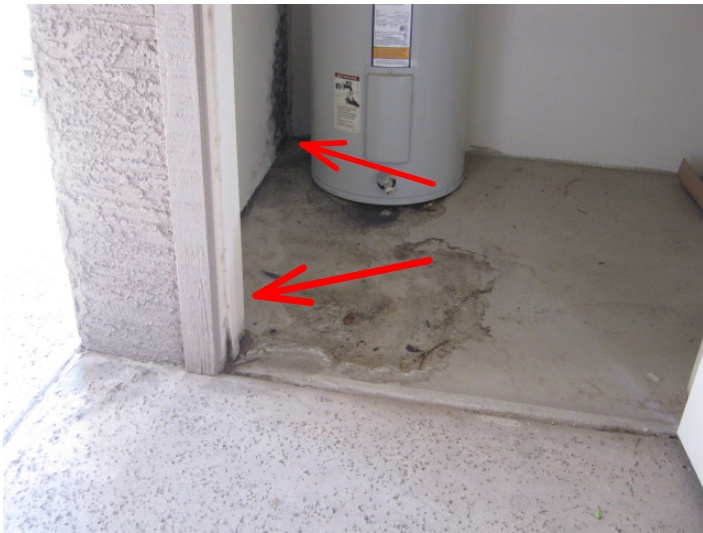
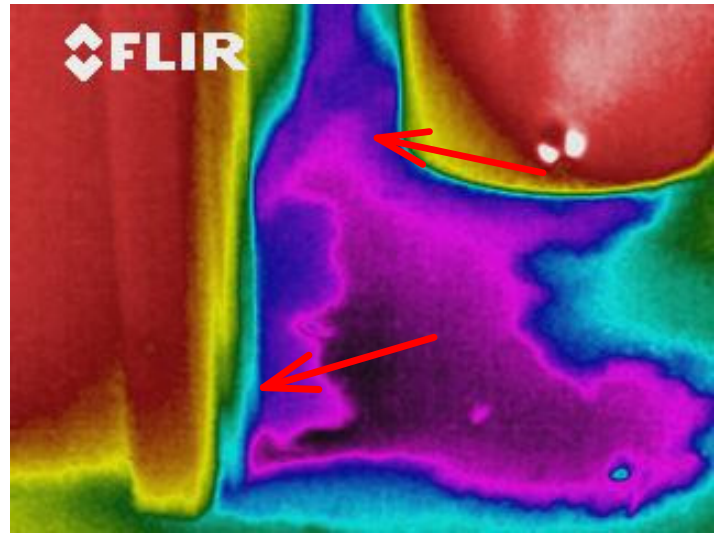
Location Floor: 2nd floor  
Location Room: storage room

**Observations:**  
The water plume can be seen flowing toward the two corners of the enclosure

Observations: The water plume can be seen flowing toward the two corners of the enclosure

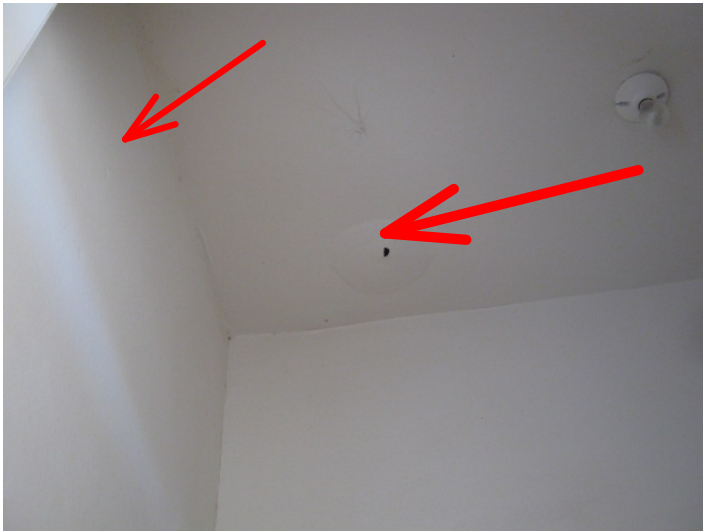
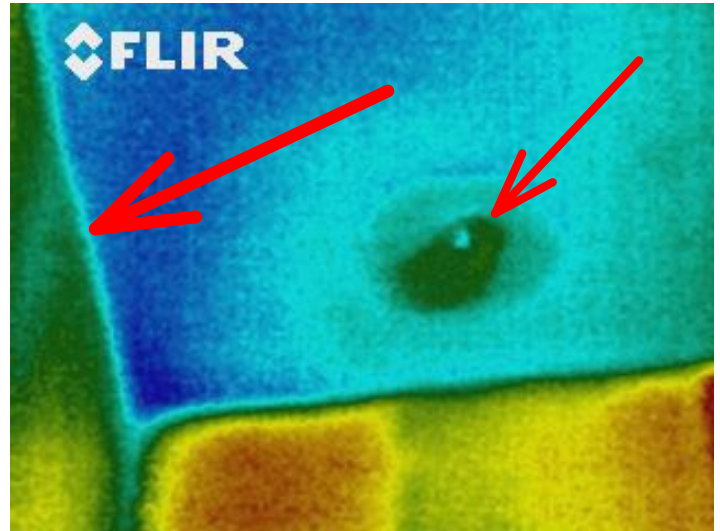
Location Floor: 1st floor  
Location Room: storage under leaky water heater

**Observations:**  
The entire ceiling is loaded with water, the water has broken through and that this has been going on for at least a week or more.

Observations: The entire ceiling is loaded with water, the water has broken through and that this has been going on for at least a week or more.

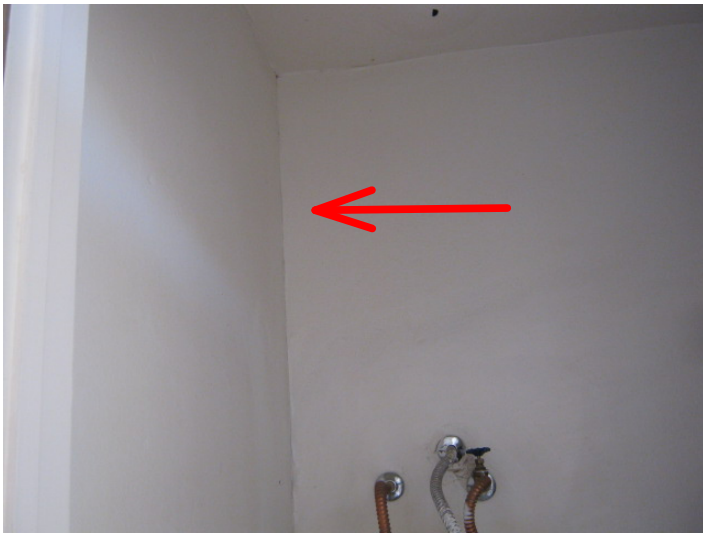
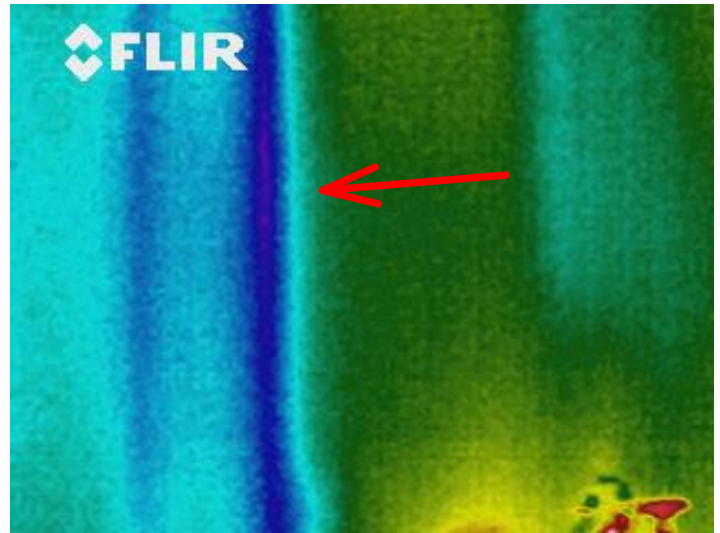
Location Floor: 1st floor  
Location Room: storage closet

**Observations:**  
The wall has water flowing through it the dark blue is wet / the corner is acing as a channel.

Observations: The wall has water flowing trough it the dark blue is wet / the corner is acing as a channel.

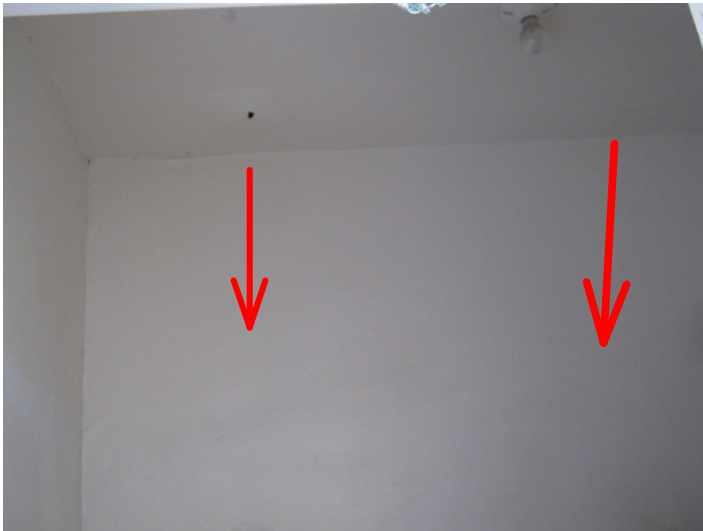
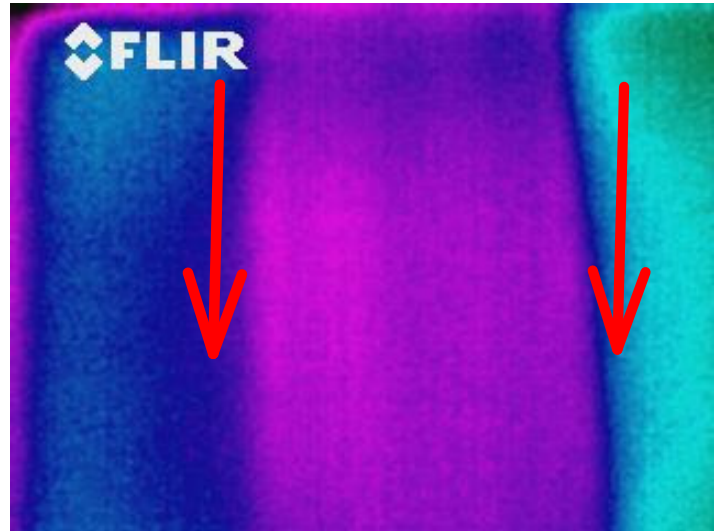
Location Floor: 1st floor  
Location Room: storage room

**Observations:**  
standing back the back wall is permeated from top to bottom with moisture.

Observations: standing back the back wall is permiated from top to bottom with moisture.
