PROPERTY CONDITION ASSESSMENT

655 E Dobson Rd, Chandler, AZ,

3/13/2007 from 11:36 AM to 5:36 PM

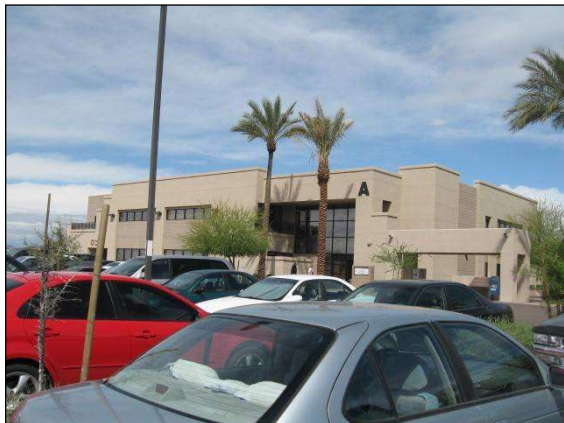
Figure 1: Building A

We do not test indoor air quality, which the Consumer product safety Commission lists fifth among potential contaminants. However, inasmuch as health is personal responsibility, we recommend having the air quality tested by a specialist, and the components through which air moves cleaned, as a prudent investment in environmental hygiene.

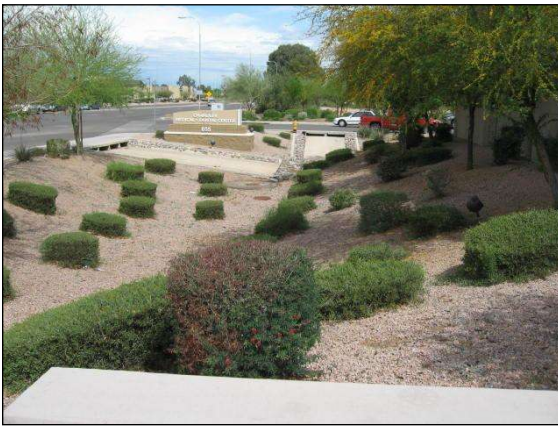
The building is situated on a flat level pad, which would typically not need a geological evaluation. However, inasmuch as we do not have the authority of a geologist you may wish to have a site evaluation.

Figure 1: drainage control

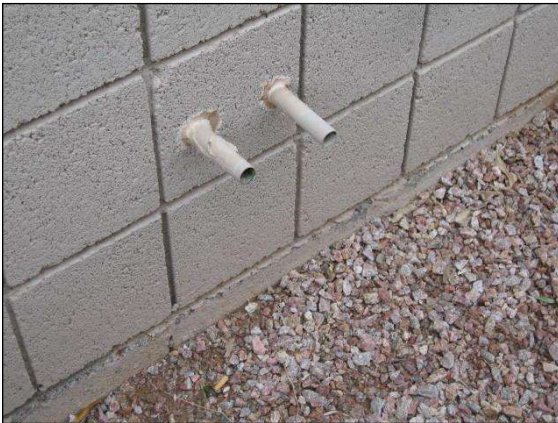
The site is served by area drains that appear to be in acceptable condition. However, because it is impossible to see inside them, the seller should guarantee that the drains are functional, or they should be flushed through to the street or other discharge points. This is important, because surface water carries silt and debris that is deposited inside the pipes and can harden in the summer months to the consistency of wet concrete, which can impede drainage and require the pipes to be cleared by a roofer service.

Figure 1: drains at site

The drainage swales on the site are clear and clean, and should be kept clean for the general maintenance of the property.

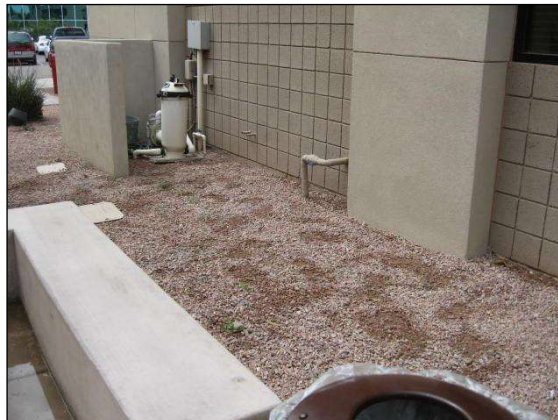
Figure 2: fountain filter system at east end of building

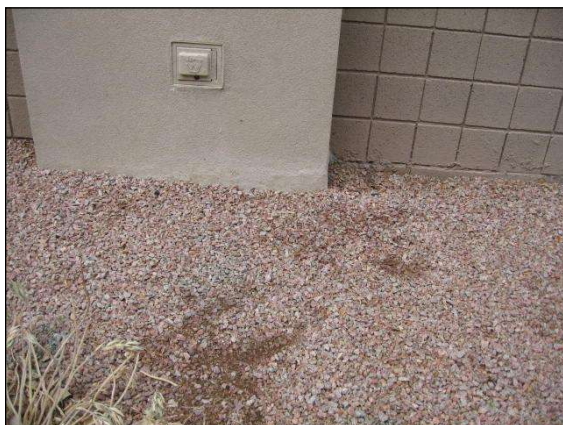
It is important to maintain a building, including painting or sealing the building walls, which provides the only barrier against deterioration. Unsealed cracks around windows, doors, and thresholds can permit moisture intrusion, which is the principle cause of the deterioration of any surface. Unfortunately, the evidence of such intrusion may only be obvious when it is raining. We have discovered leaking windows and doors while it was raining that may not have been apparent otherwise, and too often damage progresses to a point at which a window or door must be replaced. Such occurrences are not uncommon, and demonstrate why the cost of renovating a neglected property will always exceed that of having maintained it.

Figure 1: CMU wall with stucco build outs

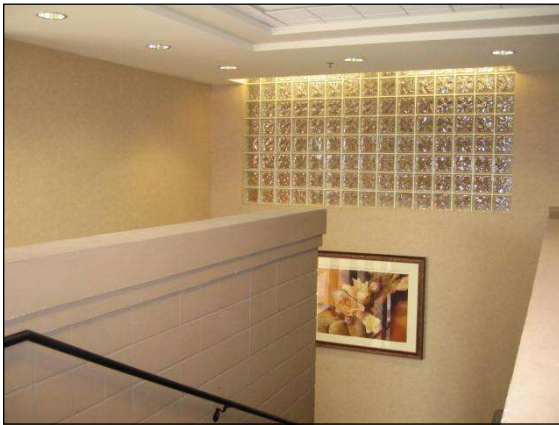
We have evaluated the stairwells, and found them to be in acceptable condition.

Figure 1: the stairwell, lights, rails and landings are in safe condition

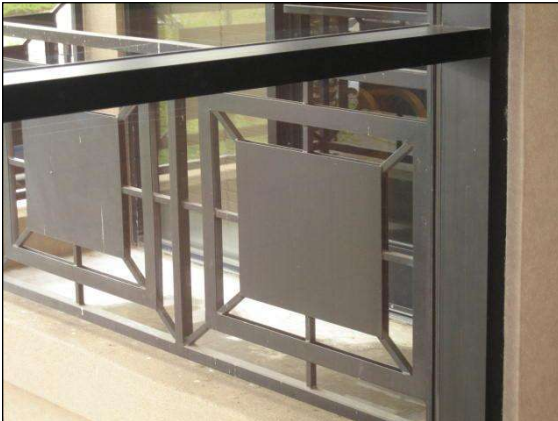
The guardrails are functional, but the standards for guardrails are not uniform. However, common safety standards require them to be a minimum of thirty-two inches high with no more than a four-inch space between the pickets.

Figure 1: guard rails are servicable

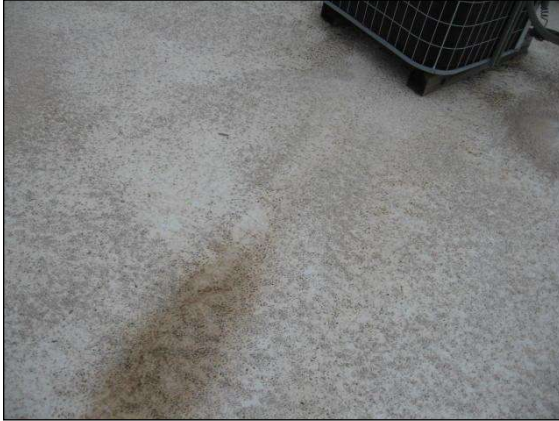
The scuppers roof drains and the drainage channels are in acceptable condition. However, without water it is difficult to judge whether they are correctly pitched to direct water into the drains, but they should function as they were intended.

Figure 1: the roof has very little ponding due to good roof drainage.

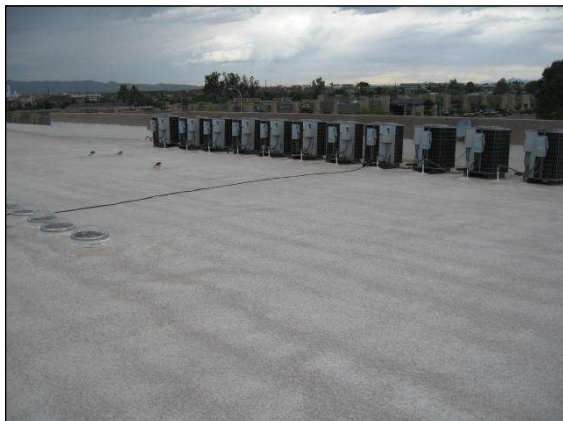
The building is served by means of forced-air split-systems 22 systems located. They are approximately 7 years old, and their components should last for twenty years if the systems are well-maintained and inspected as part of a regularly scheduled maintenance program.

Figure 1: eleven of the 22 units mounted on the roof (facing north)

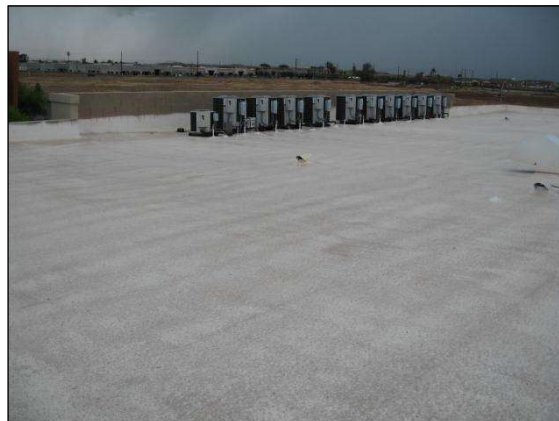
Figure 2: the southside compressors (lighting was flashing in back ground)
